Excerpt from the 2017 Anoka Water Almanac

Chapter 2: Sunrise River Watershed

Prepared by the Anoka Conservation District

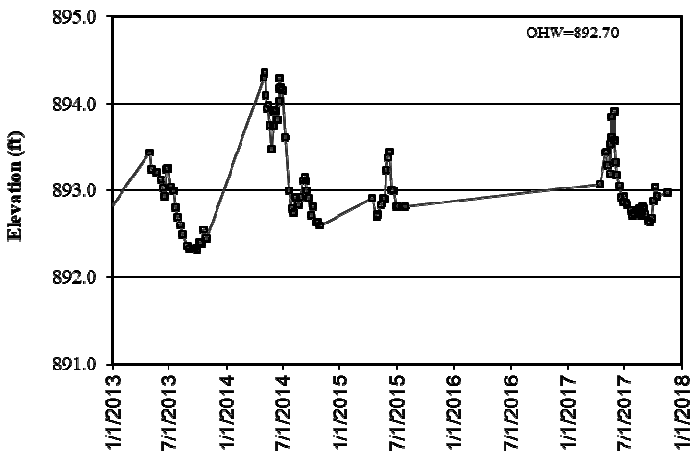
***Martin Lake Levels – last 5 years**

*No lake level data was received for Martin Lake in 2016

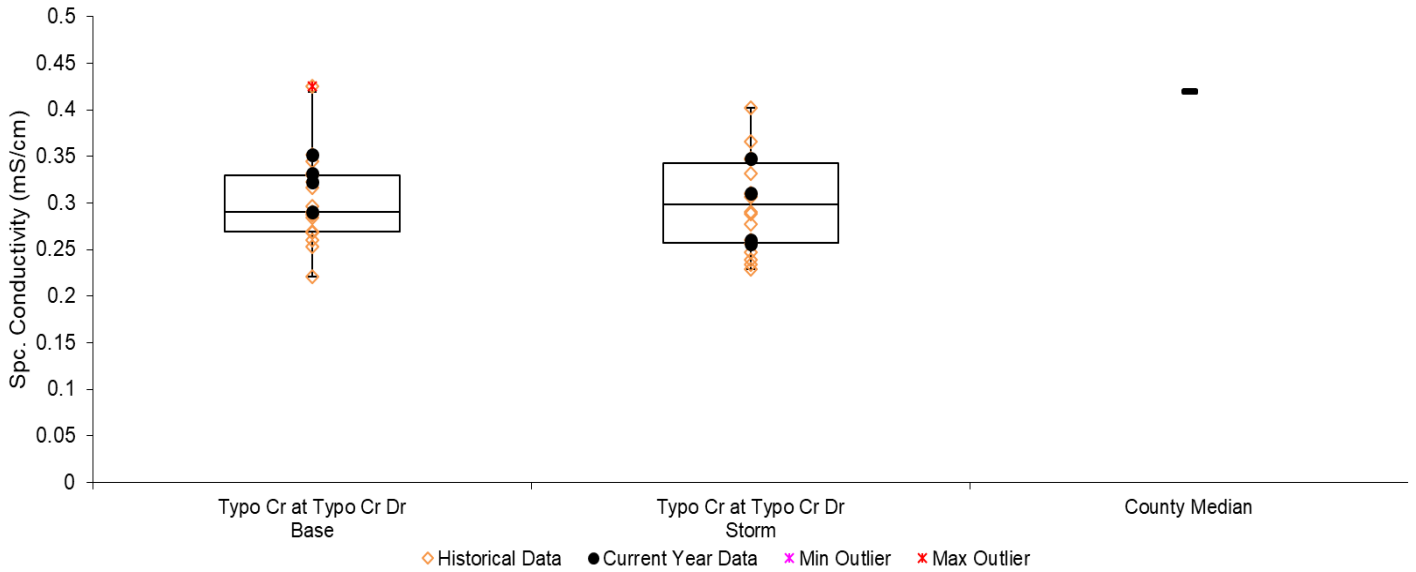
Conductivity during baseflow and storm conditions Orange diamonds are historical data from previous years and black circles are 2017 readings. Box plots show the median (middle line), 25th and 75th percentile (ends of box), and 10th and 90th percentiles (floating outer lines).

Conductivity was slightly lower during storms, suggesting that stormwater runoff contains fewer dissolved pollutants than the surficial water table that feeds the river during baseflow. High baseflow conductivity has been observed in many other area streams with the largest cause believed to be road salts that have infiltrated into the shallow aquifer.

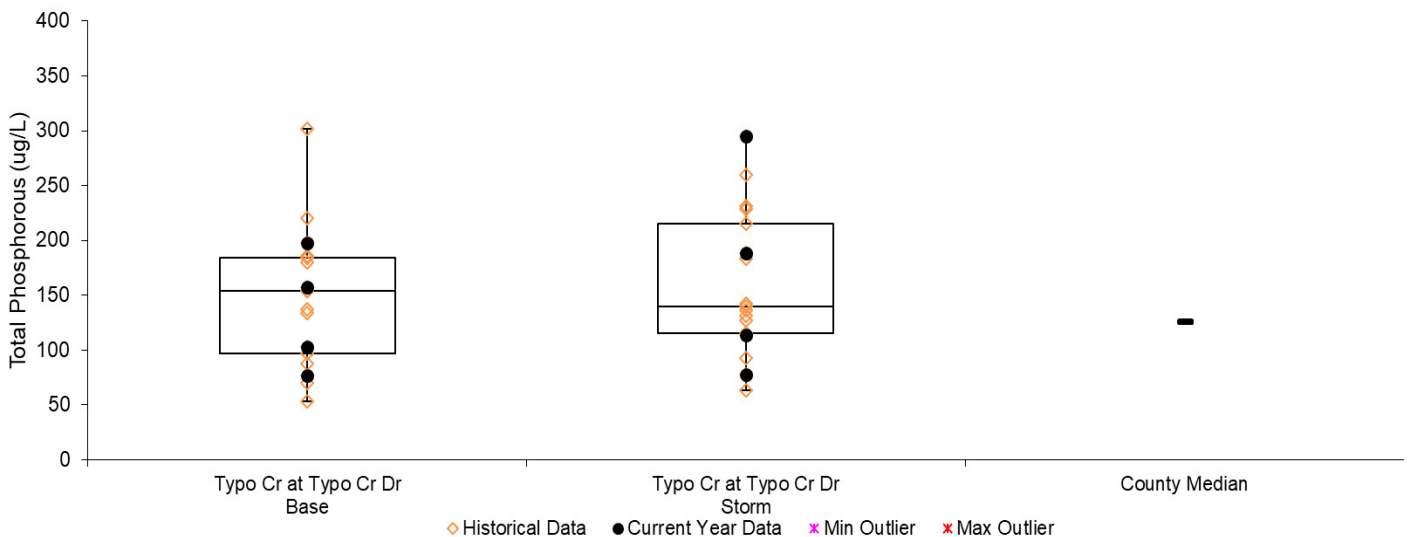
Total phosphorus during baseflow and storm conditions Orange diamonds are historical data from previous years and black circles are 2017 readings. Box plots show the median (middle line), 25th and 75th percentile (ends of box), and 10th and 90th percentiles (floating outer lines).

The nutrient phosphorus is one of the most common pollutants in our region, and can be associated with urban runoff, agricultural runoff, wastewater, and many other sources. The average total phosphorus concentration of Typo Creek in 2017 was 151 µg/L, up from the 2016 average of 138 µg/L and within the range observed since 2001.

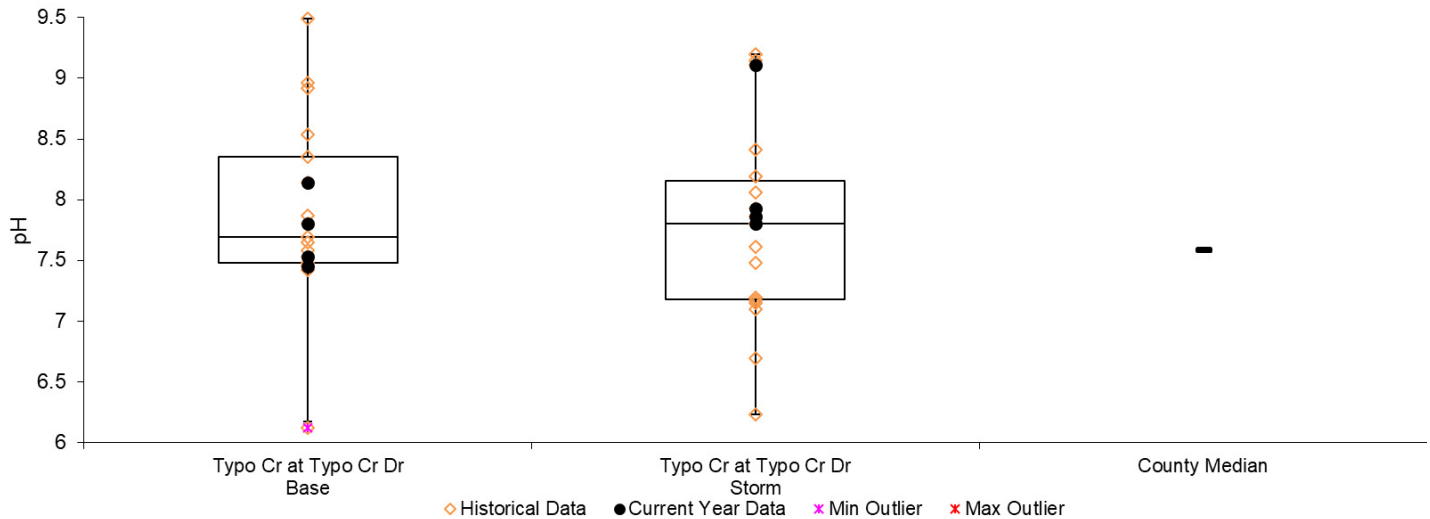
pH results during baseflow and storm conditions Orange diamonds are historical data from previous years and black circles are 2017 readings. Box plots show the median (middle line), 25th and 75th percentile (ends of box), and 10th and 90th percentiles (floating outer lines).

pH refers to the acidity of the water, and has an effect on a stream's ability to support aquatic life. The Minnesota Pollution Control Agency's water quality standard is for pH to be between 6.5 and 8.5. Typo Creek has been listed as impaired for pH since 2006 due to great swings both above and below the state standard range. In 2016, however, pH was much more stable, ranging from 7.10 to 8.06. In 2017, pH on average was higher than in 2016, but only one measurement occurred above 8.5 (9.11). These recent results are an improvement.

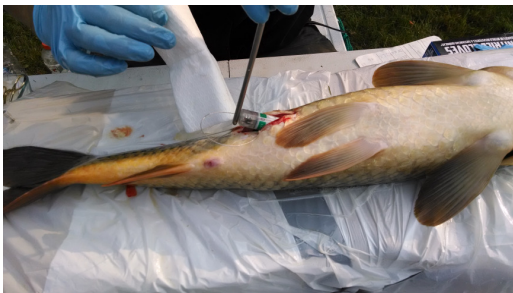
Radio transmitter being surgically implanted in a carp. A Total of 40 carp were implanted with radio loggers, 20 from each Typo and Martin Lakes. Radio loggers will help track the schooling, feeding, and movement patterns of the carp to aide in future harvesting efforts.

- 20 carp were radio tagged and released back into each Typo and Martin Lakes. These carp are being tracked monthly. They will also be used to locate schools in the winter for commercial harvest.
- 209 carp heads were preserved for aging during winter 2017-18. Fish age is determined by internal balance organs called otoliths. The population age structure reveals the spawning history.
- 2,100 carp were removed from Typo Lake using box nets.

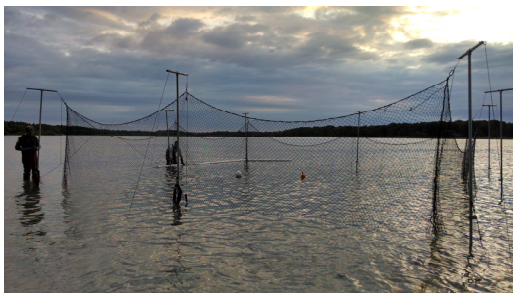
A sprung box net in Typo Lake. Nets were set, baited and sprung at three sites in Typo Lake for a total of 17 nettings on seven different days from August through October, 2017.

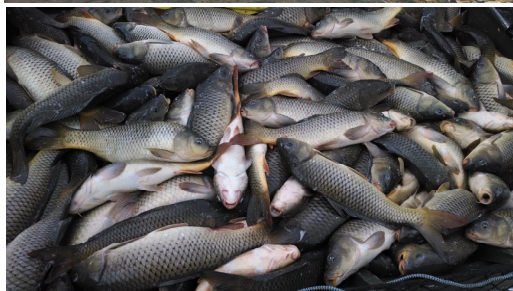
A boat full of harvested carp. A total of 2,100 carp were removed from Typo Lake during the fall of 2017. Harvest efforts in both lakes will continue through 2019.
