Excerpt from the 2013 Anoka Water Almanac

Chapter 2: Sunrise River Watershed

Prepared by the Anoka Conservation District

2013 WORK RESULTS: SUNRISE RIVER WATERSHED

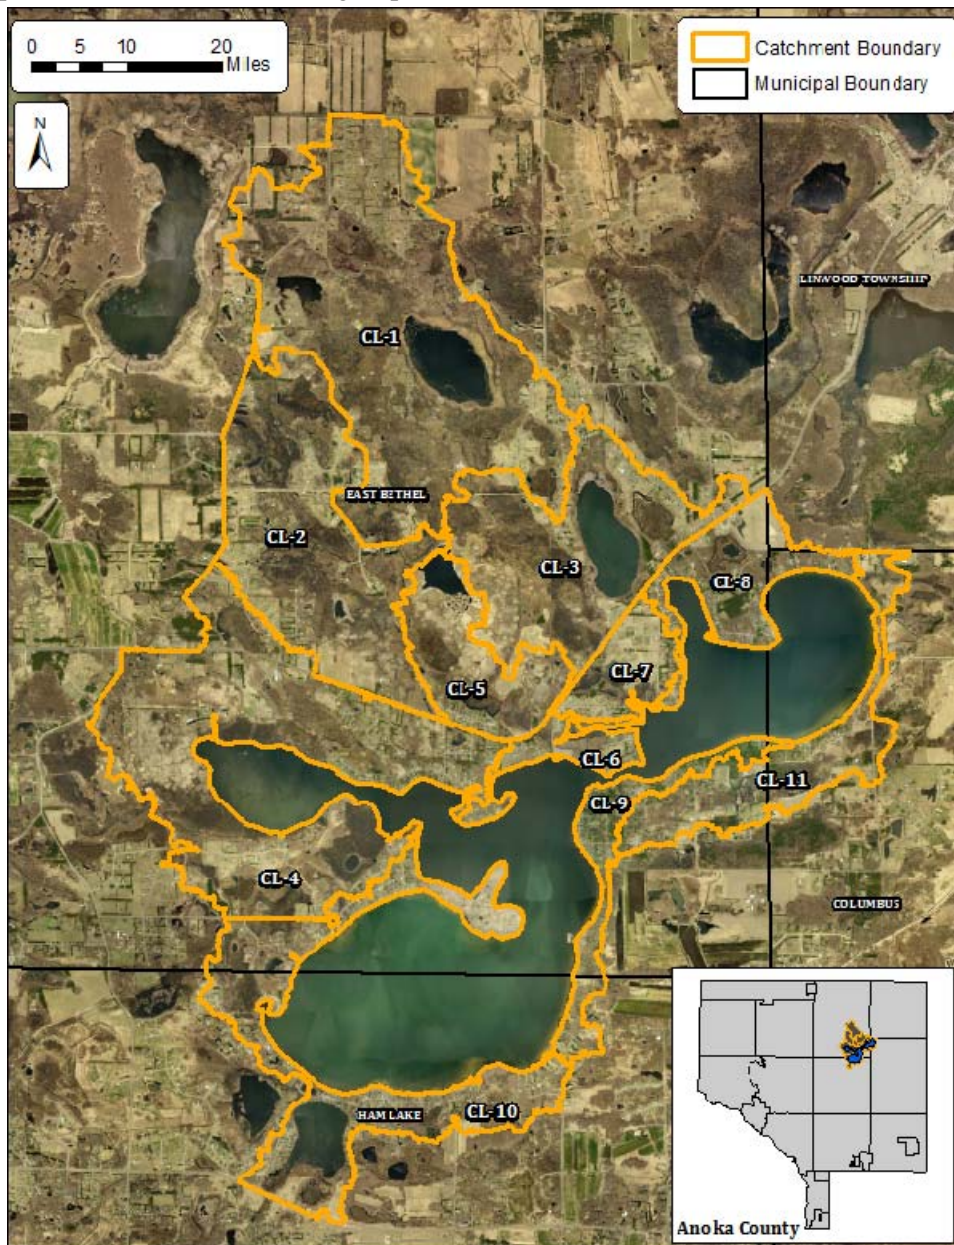
Results: The Anoka Conservation District (ACD) was contracted to complete a Stormwater Retrofit Analysis of the Coon Lake subwatershed. ACD performed watershed-wide field reconnaissance and completed GIS analysis. Potential projects have been assembled in a comprehensive list. Report preparation is in progress and will be delivered by March of 2014. Findings will be presented to WMO and lake groups.

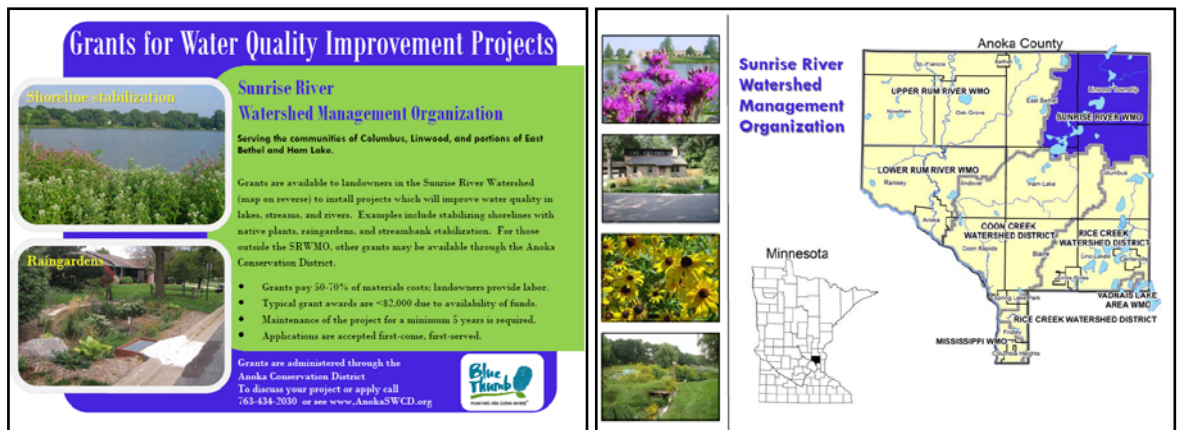
Results: Lakeshore Landscaping & Raingarden Display Board – ACD constructed a 3-panel self-standing display board comprised of information on both rain gardens and lakeshore landscaping. The display was presented by board members at Linwood Family Fun Day, East Bethel Booster Days, Columbus Arbor Day, and Lake Association meetings.
