Excerpt from the 2012 Anoka Water Almanac

Chapter 2: Sunrise River Watershed

CHAPTER 2: SUNRISE RIVER WATERSHED

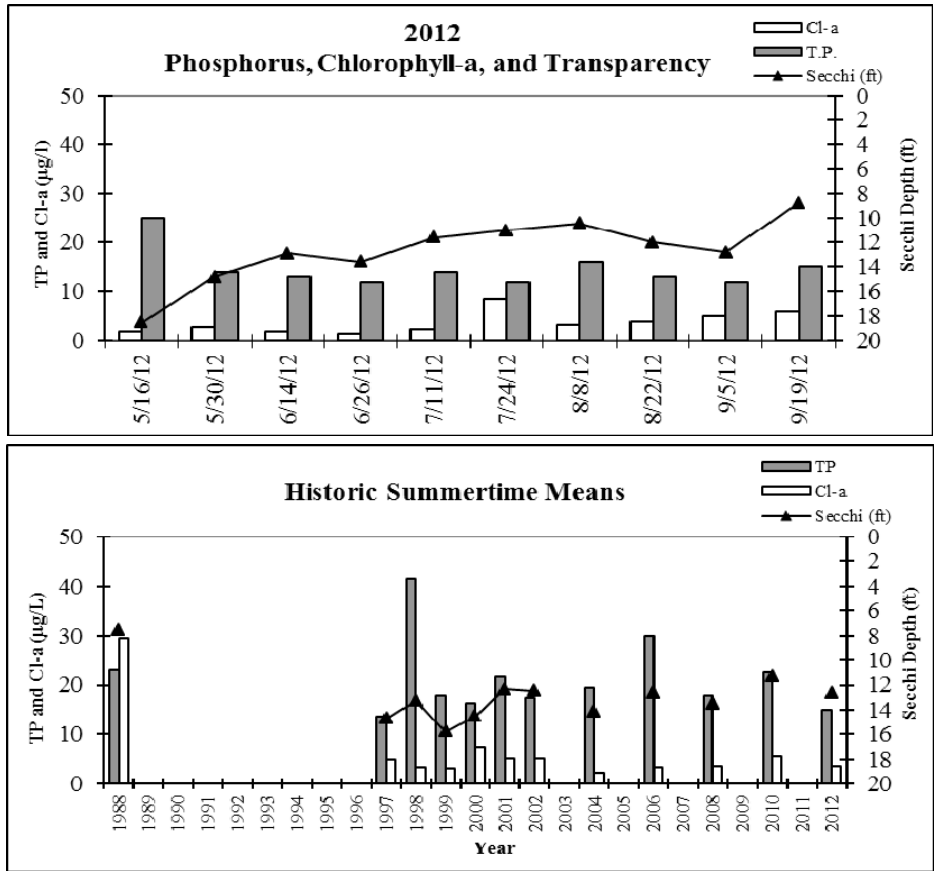
Fawn Lake Water Quality Results

Fawn Lake is classified as mesotrophic and has some of the clearest water in Anoka County. In 2012, Fawn Lake continued its trend of excellent water quality for this region of the state (NCHF Ecoregion) by receiving an overall A grade. Water clarity was high while total phosphorus and chlorophyll *a* were low throughout the 2012 sampling season. Water clarity was 18.5 feet in spring, and averaged 12.6 feet from May through September. The subjective observations of the lake's physical characteristics and recreational suitability by the ACD staff indicated that lake conditions were excellent for swimming and boating throughout the summer.

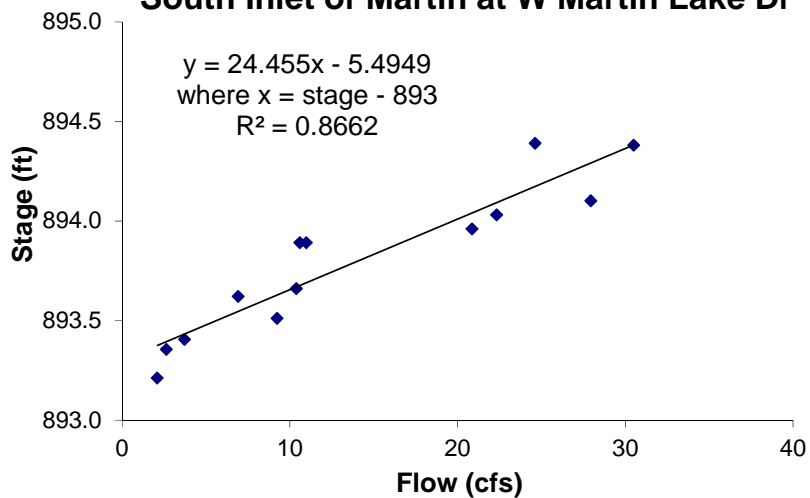
Rating Curve
South Inlet of Martin at W Martin Lake Dr

Results: Rating curves were developed for the sites listed above in previous years. In 2012 ACD staff discovered an error in the equations and corrected them. They also corrected all past hydrology records that used the equations. Below are the corrected rating curves.

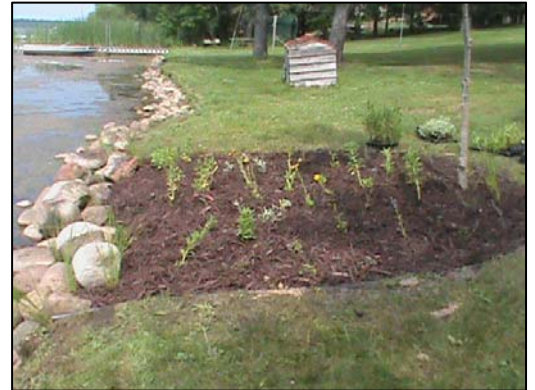
Description: Replaced turf grass with native plants. Also installed native aquatic plants at the water's edge. The project is located in place where topography leads to concentrated runoff into the lake. The project size was 98 square feet.
