Excerpt from the 2019 Water Almanac

Chapter 2: Sunrise River Watershed

Prepared by the Anoka Conservation District

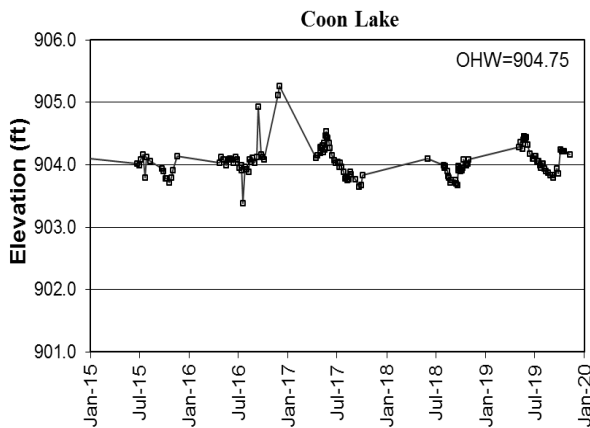
Coon Lake Levels – last 5 years

All lake level data can be downloaded from the MN DNR website’s LakeFinder feature (<https://www.dnr.state.mn.us/lakefind/index.html>). Ordinary High Water Level (OHW), the elevation below which a DNR permit is needed to perform work, is listed for each lake on the corresponding graphs below.

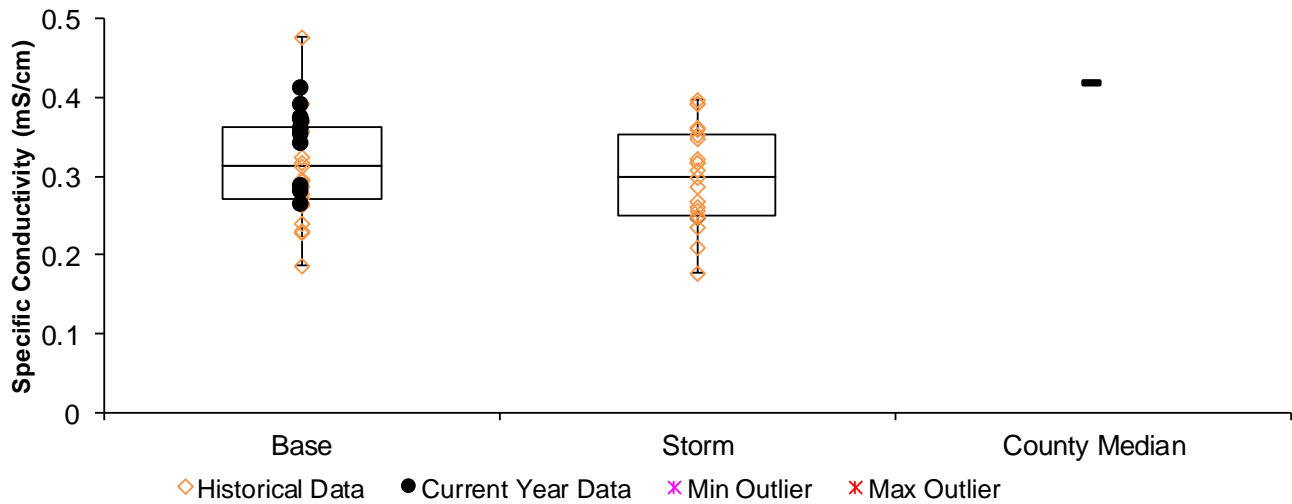
Specific conductivity during baseflow and storm conditions. Orange diamonds are historical data from previous years and black circles are 2019 readings. Box plots show the median (middle line), 25th and 75th percentile (ends of box), and 10th and 90th percentiles (floating outer lines).

Specific conductivity was acceptably low in the West Branch of the Sunrise River. Median specific conductivity for 2019 was 0.362 mS/cm. Some of the highest specific conductivity samples were observed in 2019 but the median for the site was lower than the median for Anoka County streams (0.420 mS/cm). Specific conductivity has historically been lower during storms, suggesting that stormwater runoff contains fewer dissolved pollutants than the surficial water table that feeds the river during baseflow. Increased specific conductivity levels during baseflow conditions has been observed in many Anoka County streams. This has been studied leading to the determination that the largest contributor to rising specific conductivity levels is road deicing salts that have infiltrated into the shallow aquifer.

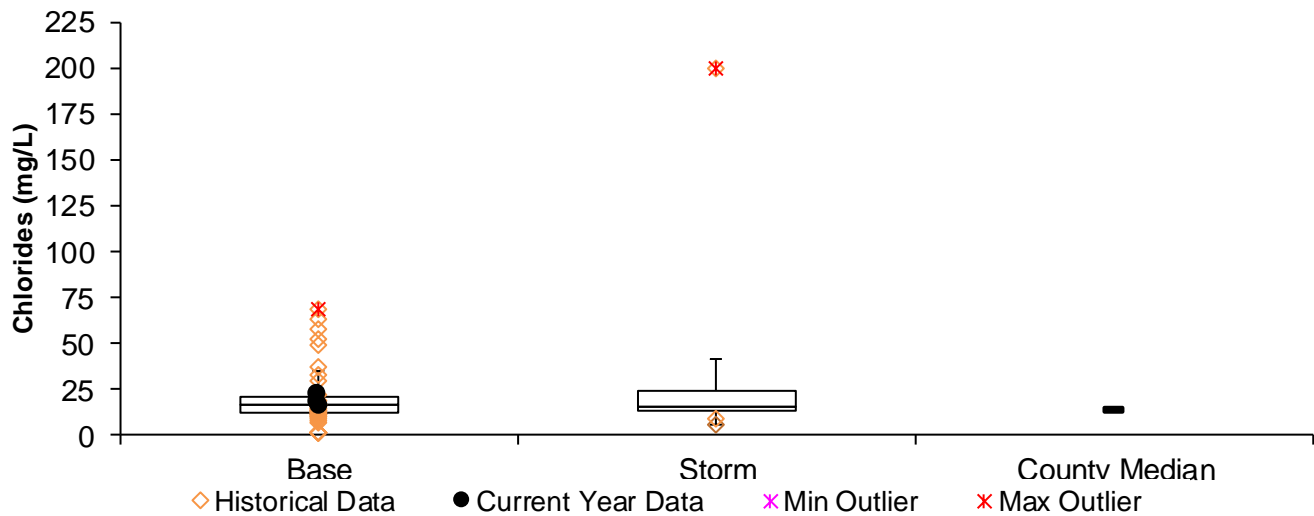
Chlorides during baseflow and storm conditions. Orange diamonds are historical data from previous years and black circles are 2019 readings. Box plots show the median (middle line), 25th and 75th percentile (ends of box), and 10th and 90th percentiles (floating outer lines).

Chlorides in the West Branch of the Sunrise River are higher than the median for Anoka County (13.29 mg/L). In 2019 the median chloride concentration was 17.2 mg/L, slightly less than in 2018 and well below the state standard of 230 mg/L. A waterbody is considered impaired if two or more samples exceed the state standard in a three-year period. This mirrors the pattern seen in specific conductivity with higher readings during baseflow conditions and further supports the finding that road deicing salts seeping into the shallow aquifer are a primary cause of higher baseflow chloride and specific conductivity readings.

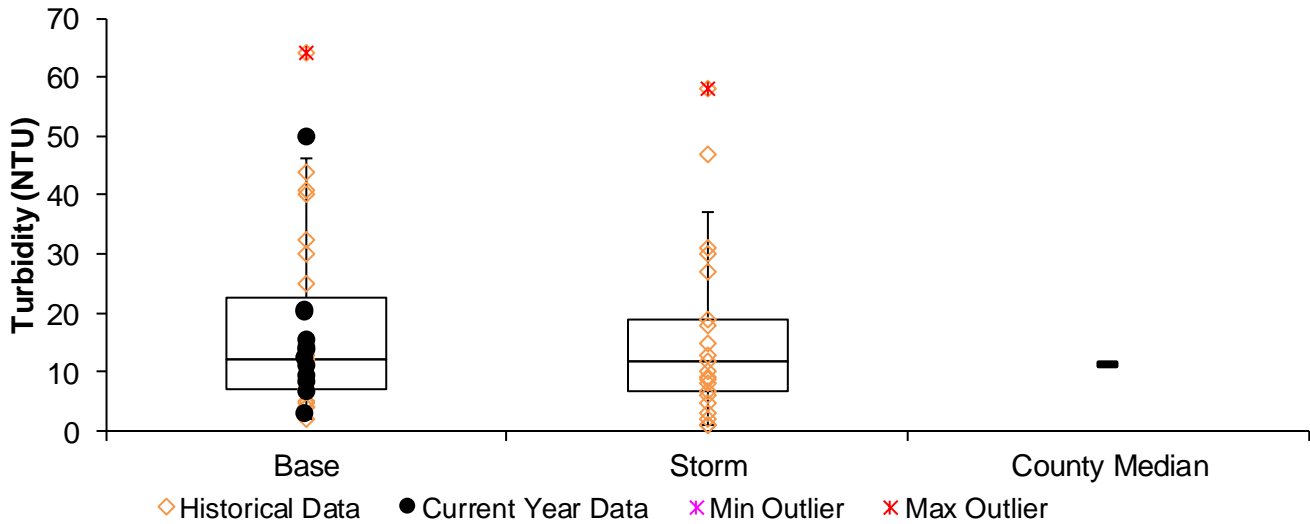
Turbidity during baseflow and storm conditions Orange diamonds are historical data from previous years and black circles are 2019 readings. Box plots show the median (middle line), 25th and 75th percentile (ends of box), and 10th and 90th percentiles (floating outer lines).

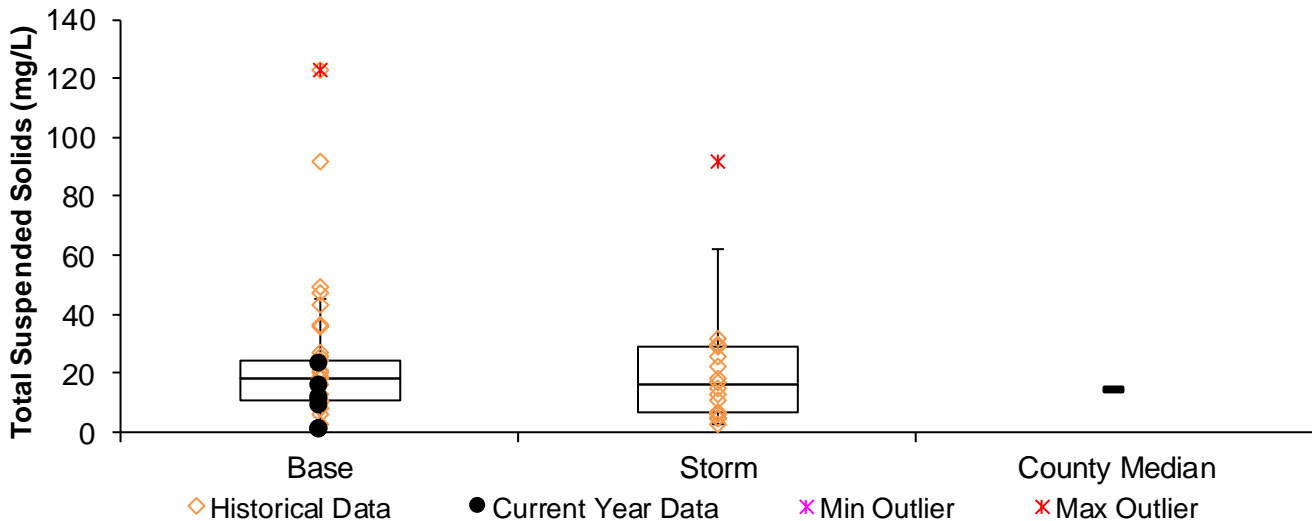
Total suspended solids during baseflow and storm conditions Orange diamonds are historical data from previous years and black circles are 2019 readings. Box plots show the median (middle line), 25th and 75th percentile (ends of box), and 10th and 90th percentiles (floating outer lines).

lakes. It's also important to recognize that the unconsolidated river bottom sediments may contribute to high TSS, especially during times of higher flow. There it little land runoff to this river downstream of Martin Lake.

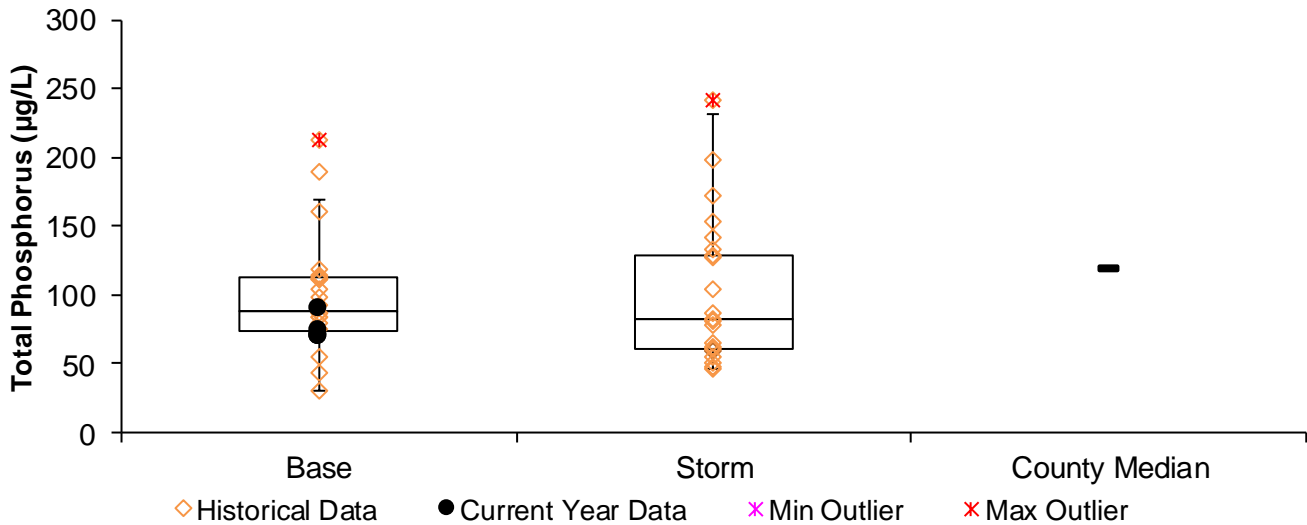
Total phosphorus during baseflow and storm conditions. Orange diamonds are historical data from previous years and black circles are 2019 readings. Box plots show the median (middle line), 25th and 75th percentile (ends of box), and 10th and 90th percentiles (floating outer lines).

The nutrient phosphorus is one of the most common pollutants in our region and can be associated with urban runoff, agricultural runoff, wastewater, and many other sources. Total phosphorus (TP) in the West Branch of the Sunrise River often exceeds the state standard of 100 µg/L. In 2019 the median phosphorus concentration was 72.0 µg/L and did not exceed the state standard in any of the five sampling events. This was a decrease from the 2018 median of 101.5 µg/L. The median phosphorus concentration in the West Branch of the Sunrise River across all years monitored is 87.0 µg/L. Over all years sampled, 21 of 53 samples (39%) have exceeded the standard of 100 µg/L. There has generally not been a large difference between storm and baseflow TP concentrations, though all 2019 sampling occurred during baseflow conditions. This likely contributed to a lower median concentration.

These phosphorus levels are common for the area. In the case of the West Branch of the Sunrise River phosphorus levels are, at least in part, reflective of conditions of Martin Lake located 3 miles upstream from the sampling site. Martin Lake is impaired for excess phosphorus, with a summertime average of 79.2 µg/L over the last 10 years. Water quality improvements to Martin Lake will benefit the river downstream. Recent upstream projects including carp barriers, carp harvests, and stormwater retrofits, coincide with improved conditions in upstream lakes, but those benefits are not yet apparent in the West Branch of the Sunrise River.

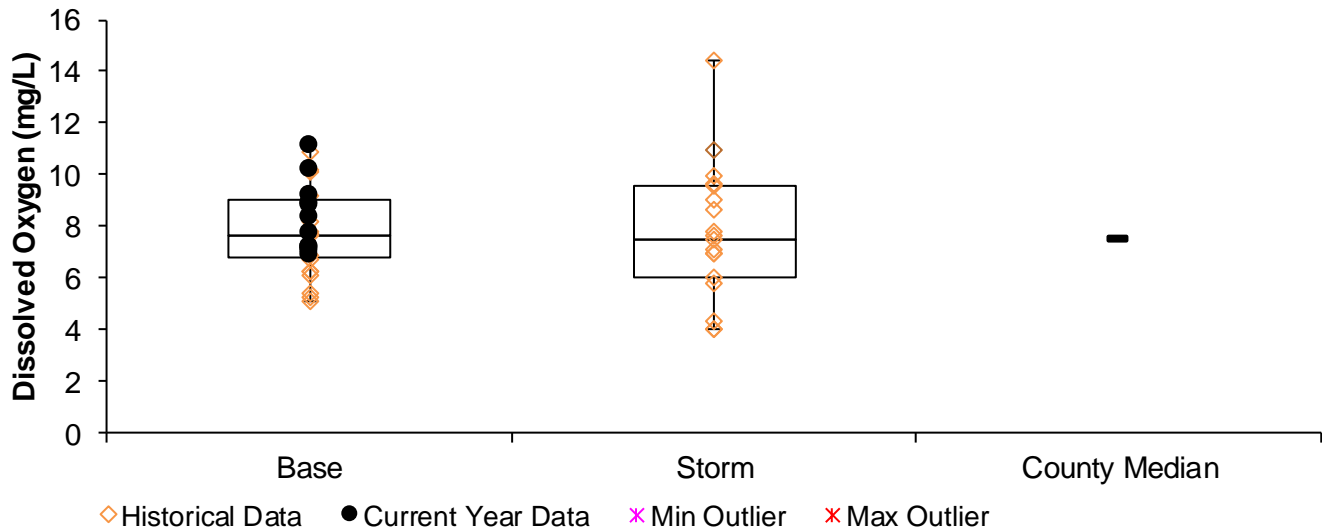
Dissolved oxygen results during baseflow and storm conditions Orange diamonds are historical data from previous years and black circles are 2019 readings. Box plots show the median (middle line), 25th and 75th percentile (ends of box), and 10th and 90th percentiles (floating outer lines).

For the West Branch of the Sunrise River there are two datasets to consider. First, spot measurements were taken with the other water quality monitoring described in this report. Dissolved oxygen has been found at less than 5 mg/L on three out of 52 occasions. All were during storm events, occurring in 2003, 2012 and 2015. In 2019, there were no instances of DO dipping below 5 mg/L, but sampling did not occur in early morning, or during storms flows.

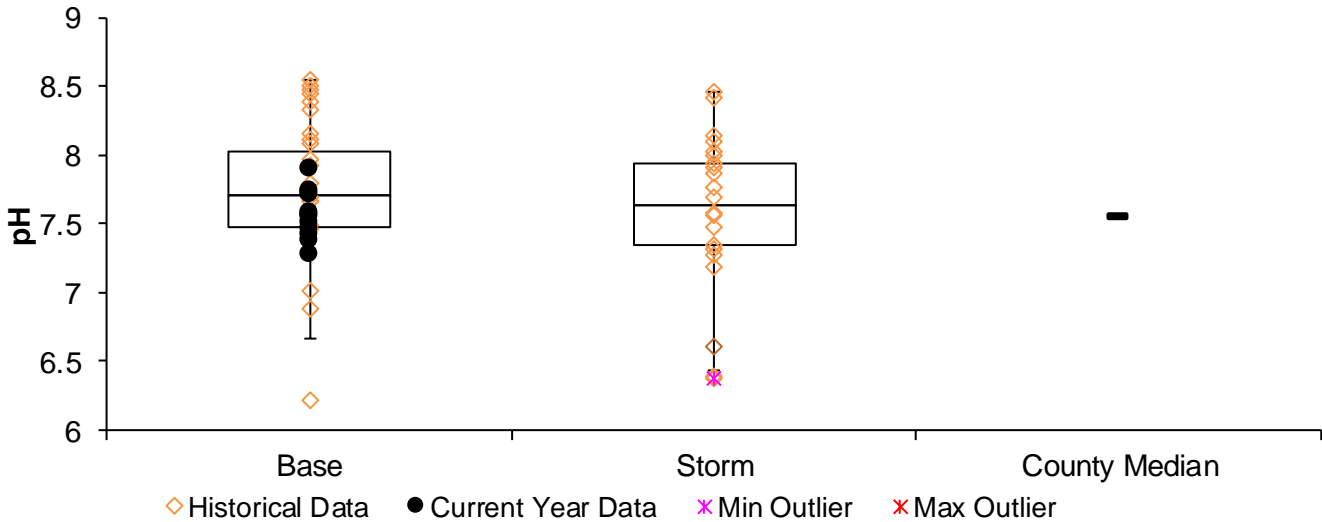
pH results during baseflow and storm conditions Orange diamonds are historical data from previous years and black circles are 2019 readings. Box plots show the median (middle line), 25th and 75th percentile (ends of box), and 10th and 90th percentiles (floating outer lines).

pH refers to the acidity of the water. The MPCA’s water quality standard is for pH to be between 6.5 and 8.5. The West Branch of the Sunrise River is regularly within this range (see figure below). It often has slightly higher pH than other streams because of the impact of algal production in upstream lakes.

It is interesting to note that pH is generally lower during storms than during baseflow. This is because the pH of rain is typically lower (more acidic). While acid rain is a longstanding problem, its effect on this aquatic system is small. In 2018, there was one occurrence of sub-standard pH in October when pH was 5.66. This is not overly concerning. pH was within the normal range (7.28 to 7.90) for all samples in 2019.

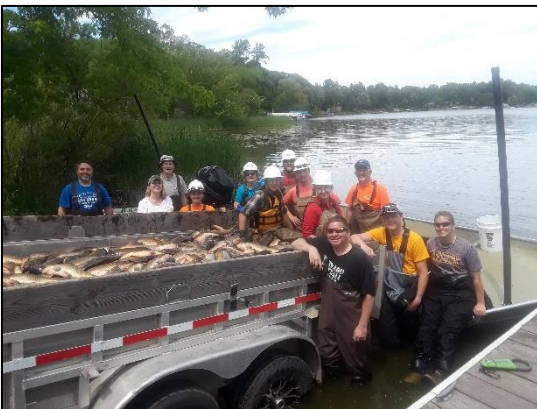
Volunteers and Carp Solutions LLC staff with carp removed at Martin Lake. 40 carp were implanted with radio loggers, 20 each from Typo and Martin Lakes. Radio loggers will help track the schooling, feeding, and movement patterns of the carp to aide in future harvesting efforts.

- Radio telemetry monitoring of carp in Typo and Martin Lakes.
- 1,863 carp were removed from Martin Lake and 999 carp were removed from Typo Lake. Total three-year total of carp removed from these lakes is now 11,879.
- Completed a long term carp management plan.
- Fully expended and closed the DNR Conservation Legacy Program grant for this project.
- Secured a new State Clean Water Fund grant to fund carp removals in 2020-2022, bringing these lakes, plus Linwood Lake, to carp density goals.
- Presented results at the annual Martin Lakers Association meeting.

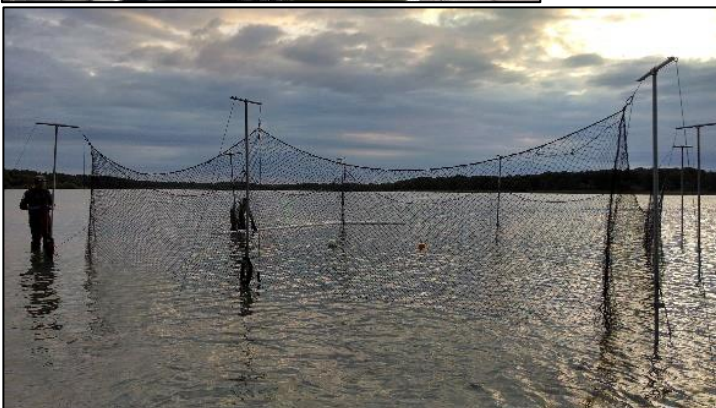
A sprung box net in Typo Lake. Nets were set, baited, and sprung at multiple sites each in Typo and Martin Lake for a total of 24 nettings on 7 different days from June through October, 2019.

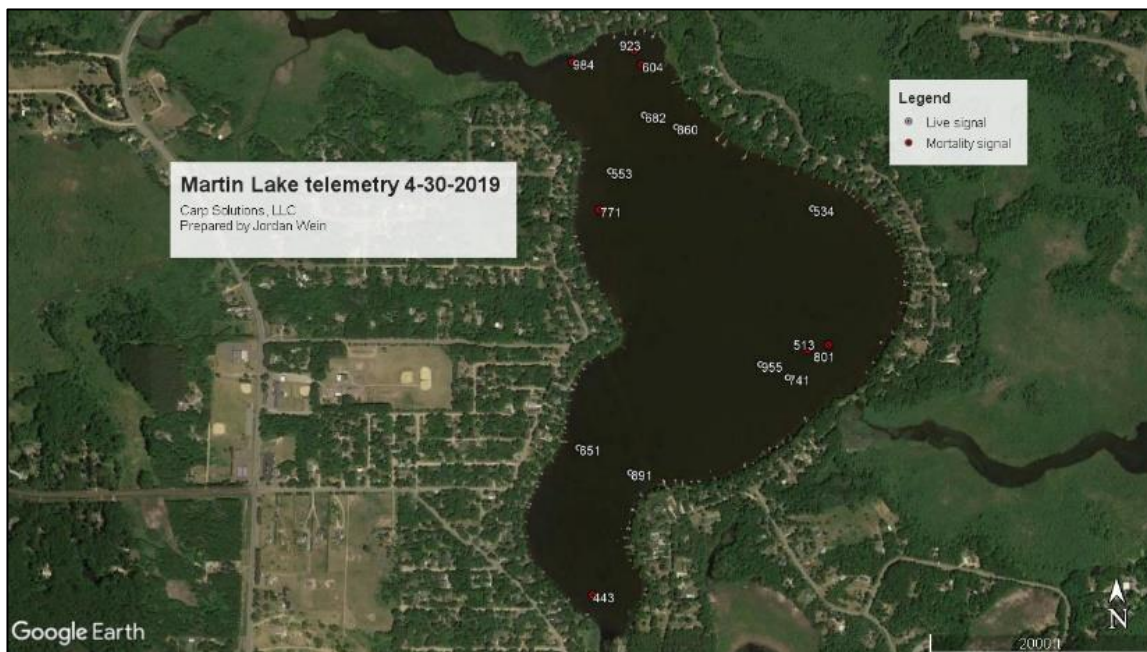
Example Telemetry Map from April 30, 2019. Radio tagged carp are periodically located to help determine seasonal movements that can direct management, such as when and where to attempt carp harvests.

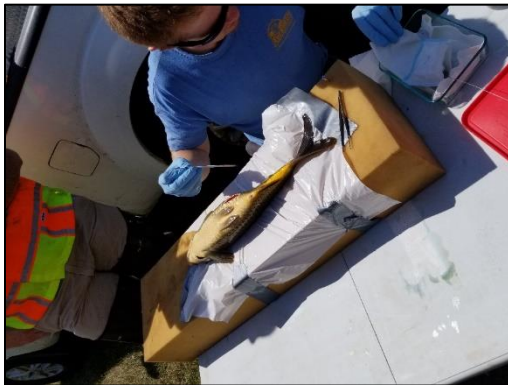
Surgical implantation of a radio tracking device in a carp at Linwood Lake.

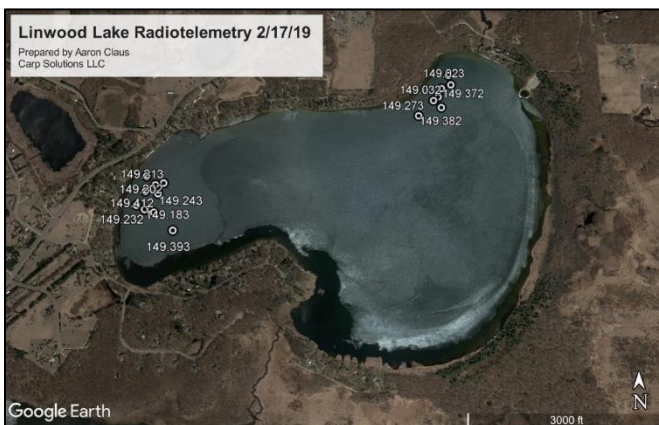
Map of carp radio tracking showing aggregations in Linwood Lake.
