Excerpt from the 2020 Water Almanac

Chapter 2: Sunrise River Watershed

Prepared by the Anoka Conservation District

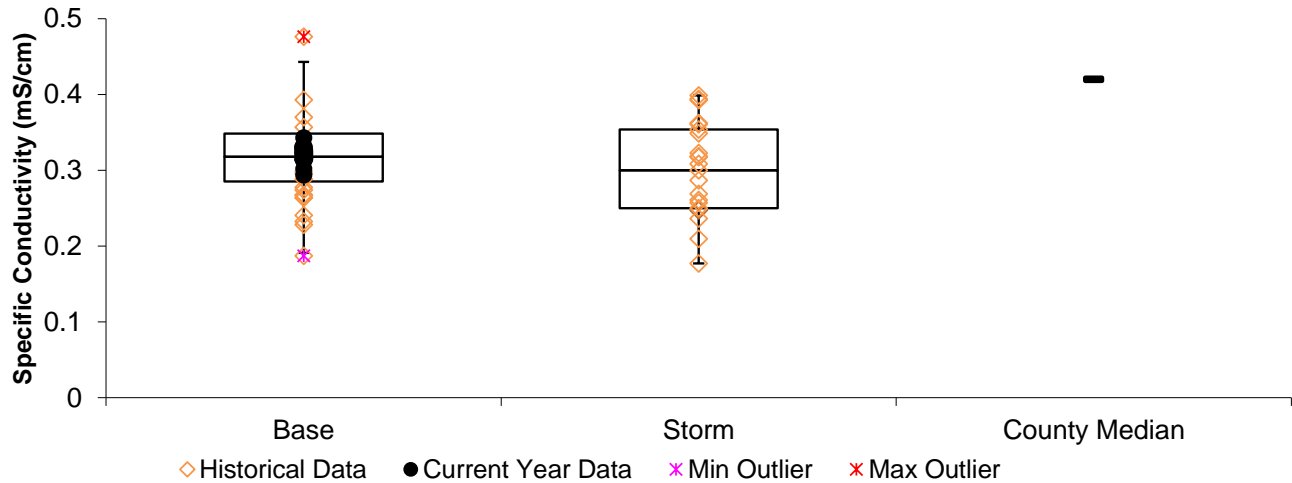
Specific conductivity during baseflow and storm conditions. Orange diamonds are historical data from previous years and black circles are 2020 readings. Box plots show the median (middle line), 25th and 75th percentile (ends of box), and 10th and 90th percentiles (floating outer lines).

Specific conductivity was acceptably low in the West Branch of the Sunrise River. Median specific conductivity for 2020 was 0.322 mS/cm. This is lower than the 2019 median which included some of the highest specific conductivity readings on record. The 2020 median for the site was also lower than the median for Anoka County streams (0.420 mS/cm). Specific conductivity has historically been lower during storms, suggesting that stormwater runoff contains fewer dissolved pollutants than the surficial water table that feeds the river during baseflow. Increased specific conductivity levels during baseflow conditions has been observed in many Anoka County streams. This has led to the determination that the largest contributor to rising specific conductivity levels is road deicing salts that have infiltrated into the shallow aquifer.

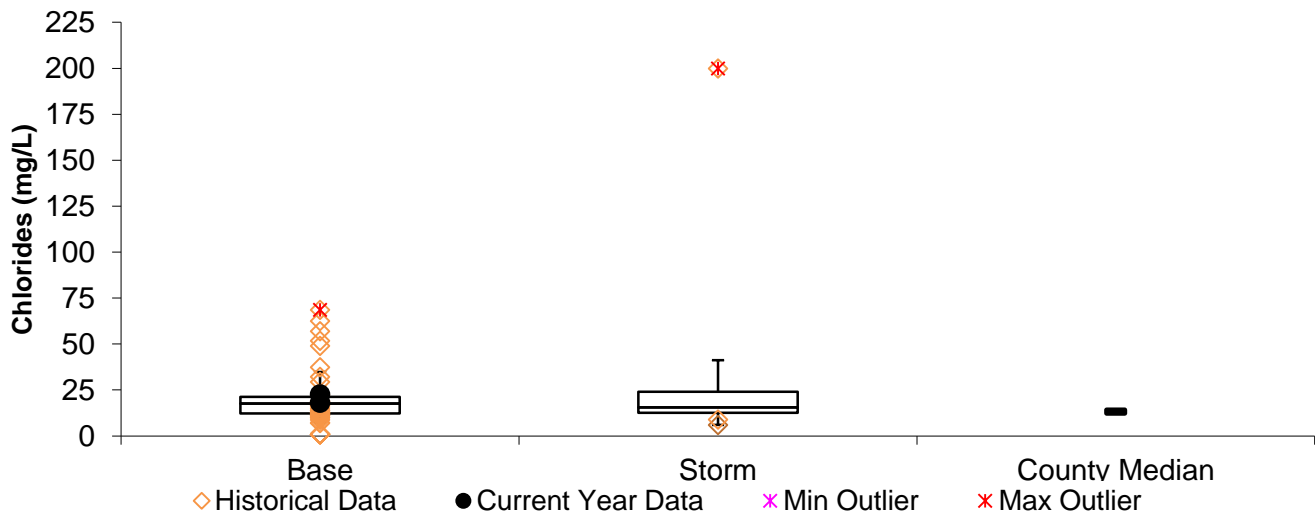
Chlorides during baseflow and storm conditions. Orange diamonds are historical data from previous years and black circles are 2020 readings. Box plots show the median (middle line), 25th and 75th percentile (ends of box), and 10th and 90th percentiles (floating outer lines).

Chloride concentrations in the West Branch of the Sunrise River are higher than the median for Anoka County (13.29 mg/L). In 2020 the median chloride concentration was 19.5 mg/L, slightly more than in 2019 but well below the state standard of 230 mg/L. A waterbody is considered impaired if two or more samples exceed the state standard in a three-year period. Only a couple of storm samples have been collected at this site for chlorides, but they have followed the pattern seen in specific conductivity with higher readings during baseflow conditions and further supports the finding that road deicing salts seeping into the shallow aquifer are a primary cause of higher baseflow chloride and specific conductivity readings.

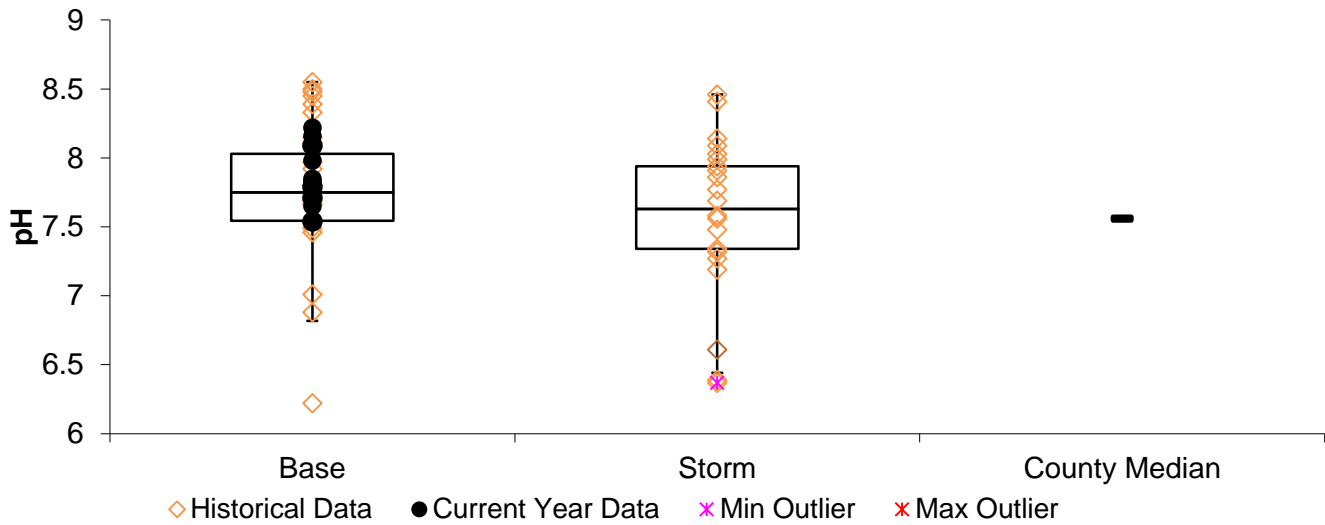
pH results during baseflow and storm conditions Orange diamonds are historical data from previous years and black circles are 2020 readings. Box plots show the median (middle line), 25th and 75th percentile (ends of box), and 10th and 90th percentiles (floating outer lines).

pH refers to the acidity of the water. The MPCA’s water quality standard is for pH to be between 6.5 and 8.5. The West Branch of the Sunrise River is regularly within this range (see figure below). It often has slightly higher pH than other streams because of the impact of algal production in upstream lakes.

It is interesting to note that pH is generally lower during storms than during baseflow. This is because the pH of rain is typically lower (more acidic). While acid rain is a longstanding problem in some areas, its effect on this aquatic system is small. In 2018, there was one occurrence of sub-standard pH in October when pH was 5.66. This is not overly concerning. pH was within the normal range (7.54 to 8.22) for all samples in 2020.

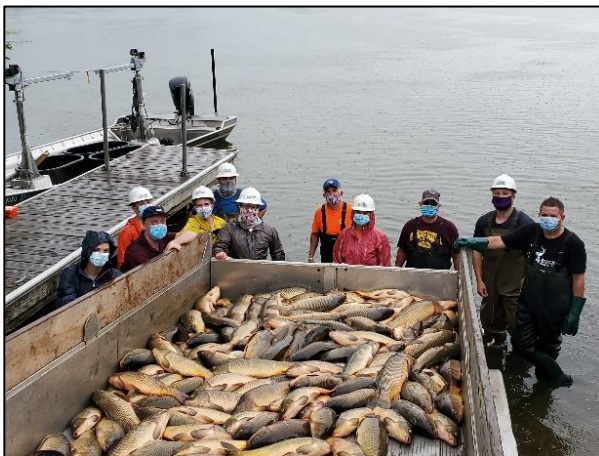
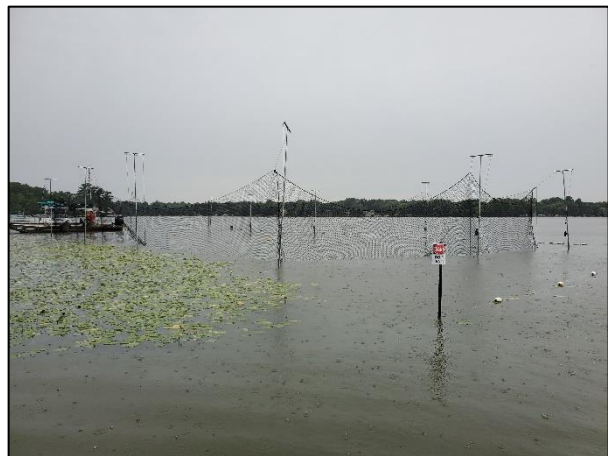
ACD staff, volunteers and Carp Solutions staff with carp removed from Martin Lake (left image) by box net (right). Carp were removed with box traps.

- 739 carp were removed from Martin Lake. 5,967 carp have now been removed from this lake since 2018.
- 30 carp were removed from Linwood Lake. This was the first year of efforts at this lake. The spring seine that captured these carp had a number of radio-tagged carp in the net indicating a large catch until the net had to be lifted over obstacles.
- Planned carp removals for 2021 which will include Linwood, Martin and Typo Lakes.
- Presented results at the annual Martin Lakers Association meeting.
