MOLITOR PROPERTY

Pre-Buffer Conditions

After Lakeshore Restoration

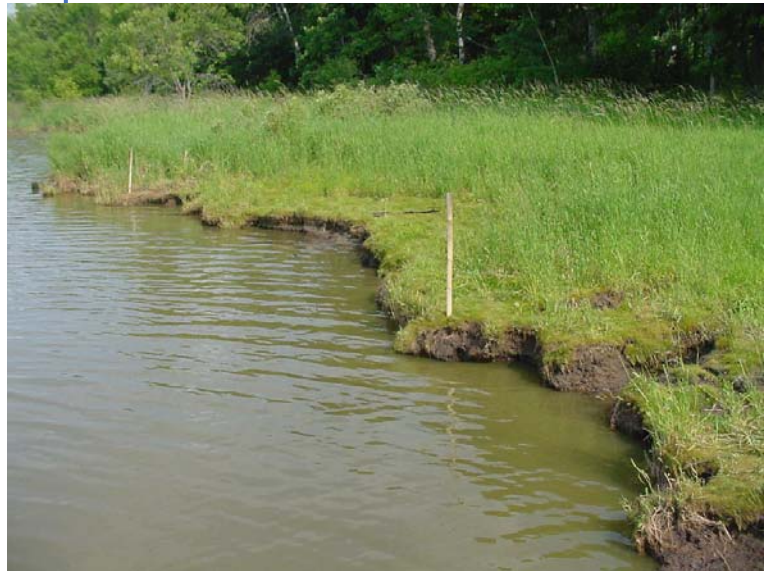
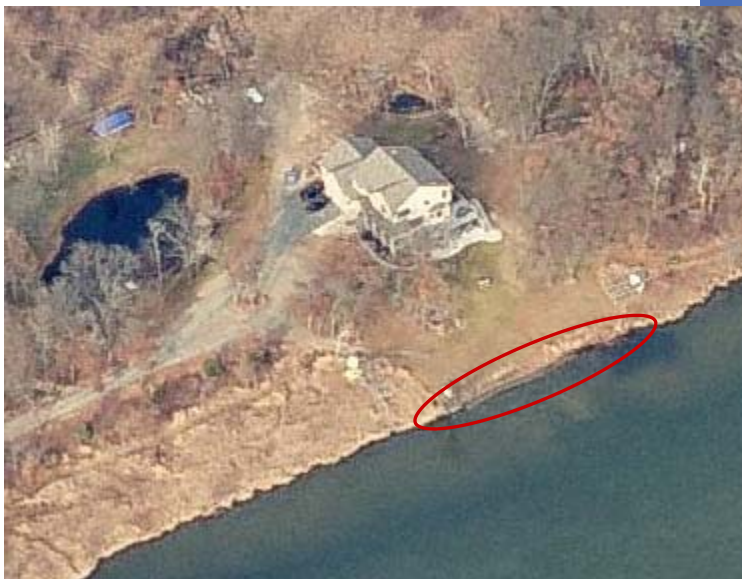
The Molitor property lies on the shore of Typo Lake. Their site was previously maintained with mown turf the lake's edge. This practice resulted in:

- Active shoreline erosion due to limited root structure to withstand wave action and animal activity
- Direct conveyance of nutrients and pollution from the property into the lake, increasing algae and unwanted aquatic vegetation blooms
- Limited plant diversity
- Limited fish and wildlife habitat

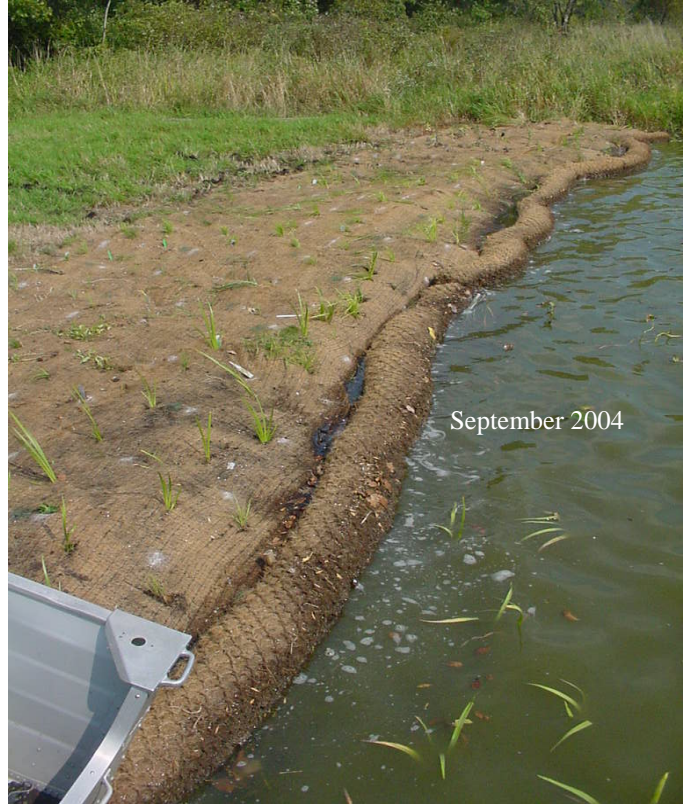
September 2004

Biologs were anchored along the eroding shoreline to stop further erosion and help establish a native plant community. A variety of aquatic plants were planted into and around the biologs. Erosion control fabric was anchored immediately upland of the biologs and a variety of native upland plants were planted throughout. This lakeshore buffer has many benefits, including:

- The repair of active erosion and prevention of further problems
- The shoreline is stabilized to help the native plants establish
- Plant diversity will dramatically increase and the new root structure will help protect the shoreline from erosion due to runoff and wave action
- Fish and wildlife habitat will increase
- Storm water is slowed and retained as it flows toward the lake increasing infiltration and decreasing input of nutrients and pollutants into Locke Lake
