2012 Annual Report

East Bethel – Ham Lake – Linwood - Columbus

April 19, 2013

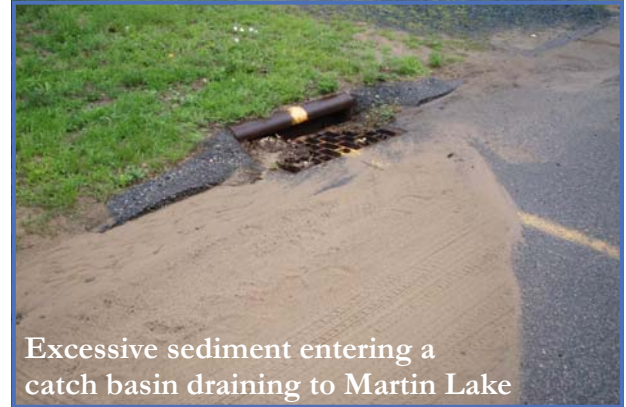
Excessive sediment entering a catch basin draining to Martin Lake

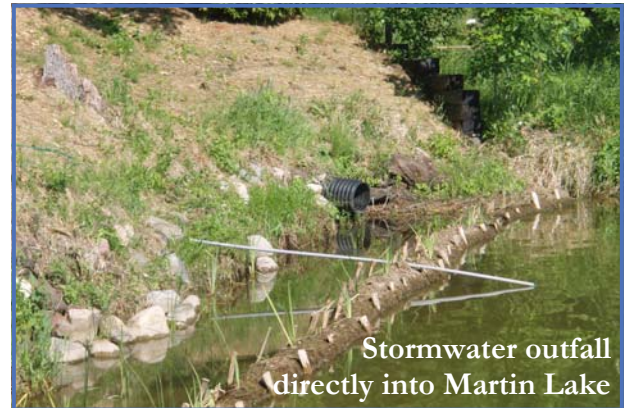
Stormwater outfall directly into Martin Lake

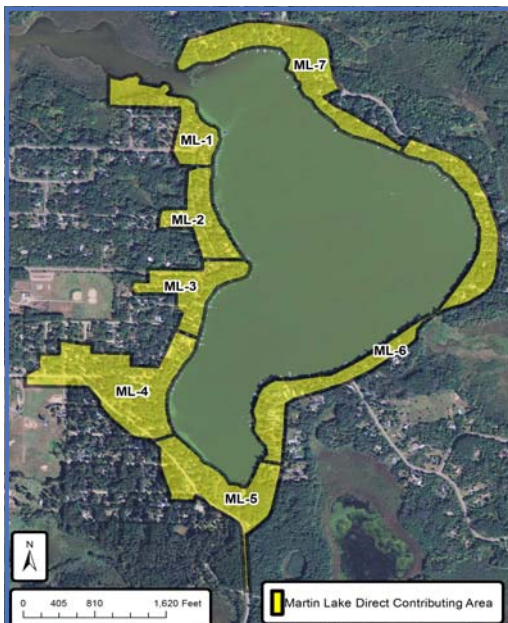
GIS and WinSLAMM Modeling

A GIS database has been generated that includes detailed catchment drainage delineation and existing stormwater infrastructure mapping. Existing and proposed stormwater treatment for each catchment were modeled using WinSLAMM software. The table below highlights characteristics of the subwatershed as well as preliminary WinSLAMM model outputs representing total phosphorus (TP) and total suspended solids (TSS) annual loads generated within the areas directly draining to Martin Lake (see map to left).

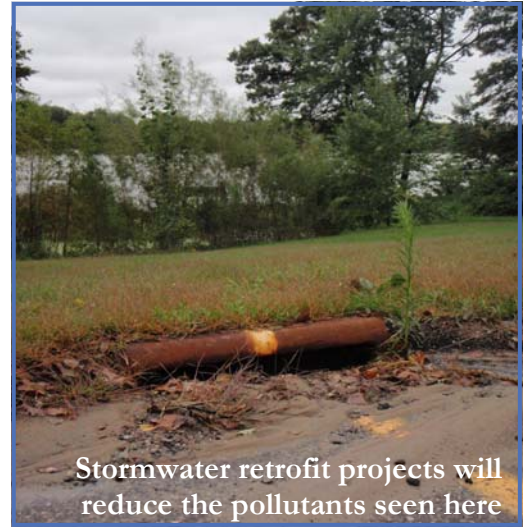
Curb-cut Rain Gardens

Curb-cut rain gardens receive stormwater runoff from the existing curb and gutter system and infiltrate quickly to avoid standing water (see pictures to right). In addition to recharging the groundwater which helps maintain stable water levels in Martin Lake, the rain gardens remove pollutants and nutrients that would otherwise flow directly into the lake.

The high infiltration rates present across the Anoka sand plain are ideal for retrofit practices such as the curb-cut rain garden pictured to the left in a computer simulation. In addition, curb-cut rain gardens do not require large areas of open space, and would therefore work well in the areas surrounding Martin Lake.

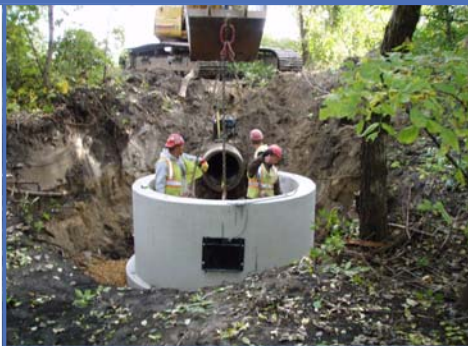
New Ponds and Pond Retrofits

New ponds and pond retrofits can provide treatment for large drainage areas by removing nutrients and pollutants from stormwater before it enters Martin Lake.

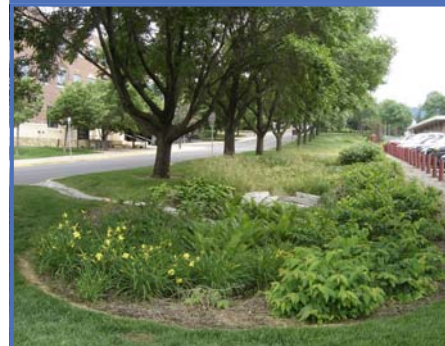
Swales promote filtration and infiltration of stormwater runoff and can be installed in opportunistic locations such as ditches that are otherwise unsightly.

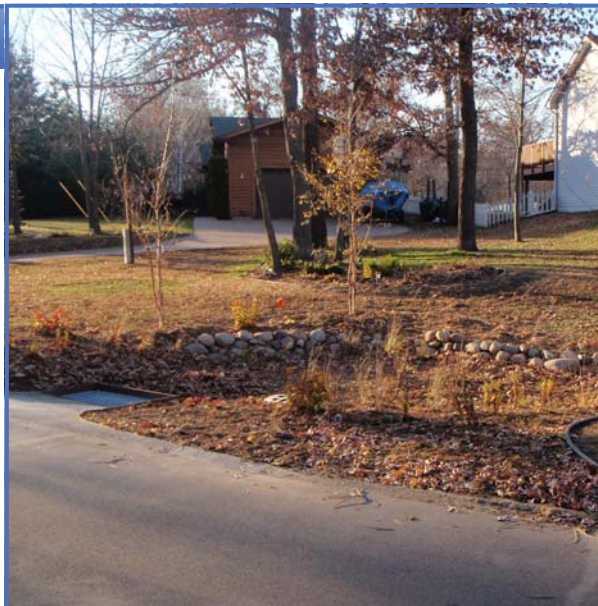
More specifically, stormwater is diverted into the rain gardens via a curb-cut and concrete inlet. The natural hydrological cycle is restored as water infiltrates through the soils and the native plant community promotes evapotranspiration. Long term maintenance will be conducted by the landowners under an agreement with the SRWMO.

Rain Gardens Installed 3
Date Installed November 2011
Live Storage Area 860 ft²
Watershed Treated 4.72 acres

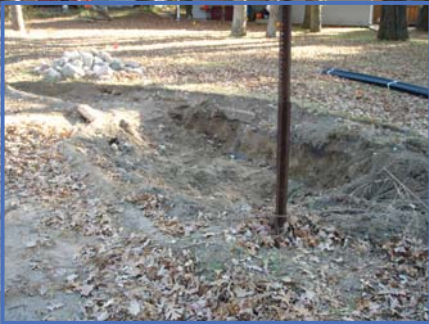
1. Site preparation and soil excavation to achieve desired side slopes and 1 ft. maximum ponding depth.

2. Retaining wall construction. Retaining walls can be built using traditional landscape blocks or natural stone, as seen here.

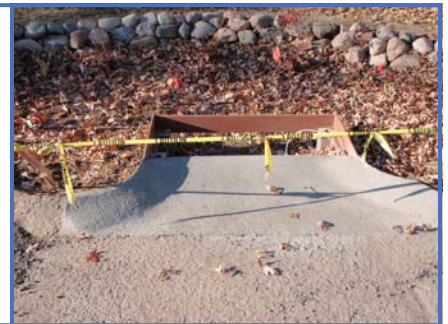
3. An 8" soil auger was used to drill 36" deep holes throughout the rain garden basins to remove any existing soil compaction and ensure acceptable infiltration rates.

4. Curb-cut construction to accept offsite runoff from curb and gutter system.

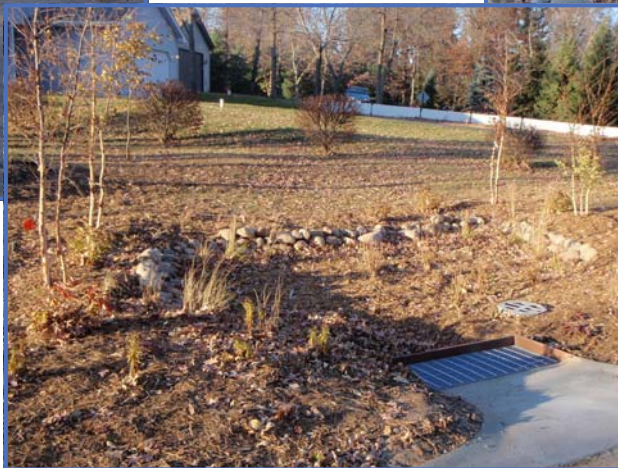
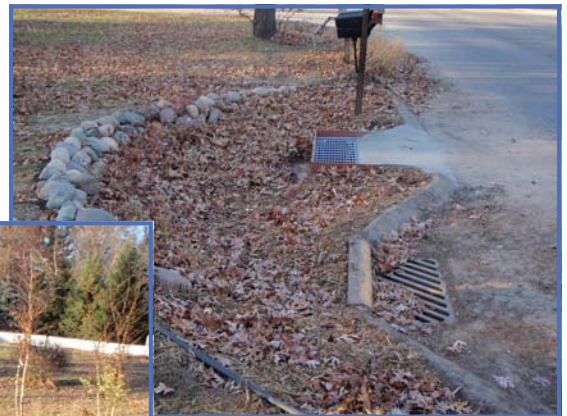
Fully functioning curb-cut rain gardens within ML-3 and ML-5. Note the pretreatment chambers that filter incoming runoff and also prevent debris and sediment from entering or exiting the rain gardens when filled to capacity.

Post-project monitoring will verify acceptable rain garden infiltration rates and proper pretreatment chamber function following storm events. Monitoring will occur during the 2012 growing season to ensure proper garden function and successful plant establishment.

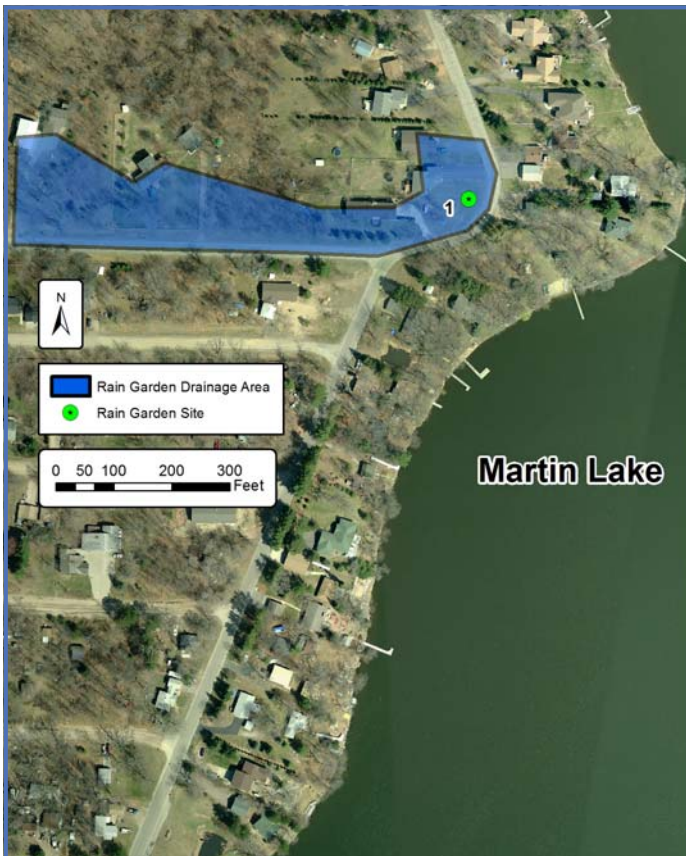
Installed rain garden site and drainage area in ML-3.

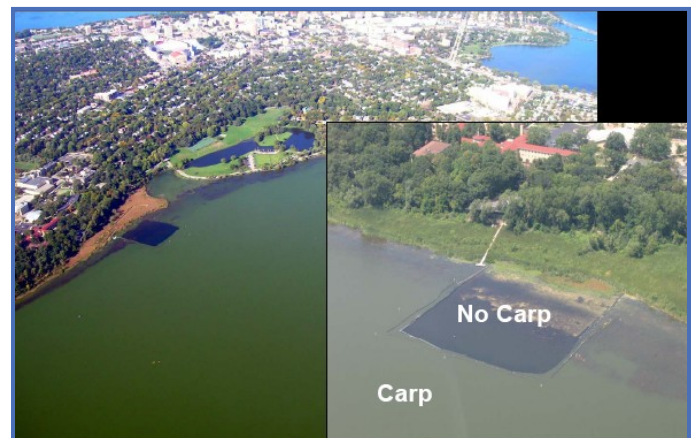
Carp exclusion curtain on Lake Wingra, WI shows potential water quality improvement when carp are controlled.

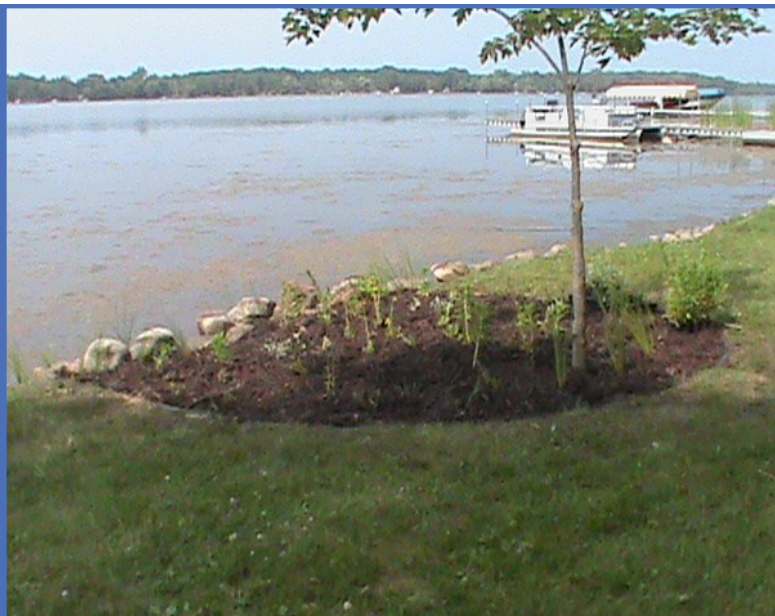
Lakeshore restorations provide aesthetic appeal, increased wildlife habitat, and water quality benefits. A restoration was completed during the summer of 2012 on a residential property that borders Linwood Lake in Wyoming. Pre-project conditions consisted of mown turf grass to the water's edge, which contributed excessive runoff to the lake. The restoration involved sod removal, erosion control blanket installation, and planting of native species plugs. Final planting occurred during the 2012 annual lake association meeting to serve as an example of a simple and inexpensive project to other homeowners on Linwood Lake. Funding for the project was provided through a combination of Sunrise River Watershed Management Organization (SRWMO) Water Quality Cost Share, landowner contribution, and native plant donation by Native Plant Nursery, Inc.

Completed project in the summer of 2012.

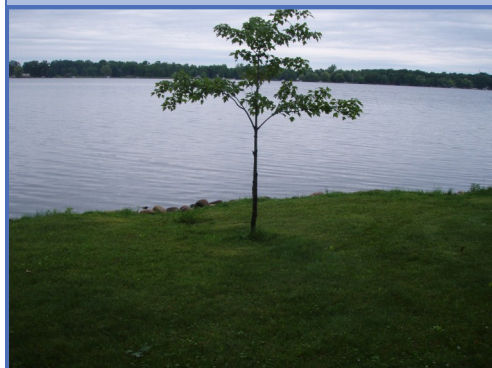
Pre-restoration conditions consisted of mown turf grass and Creeping Charlie, which provided no benefits to water quality, wildlife habitat, or shoreline stability.

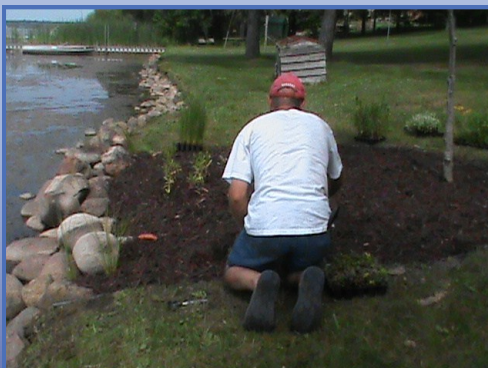
Sod was removed prior to the installation of erosion control blanket, shredded hardwood mulch, landscape edging, and native plant plugs.

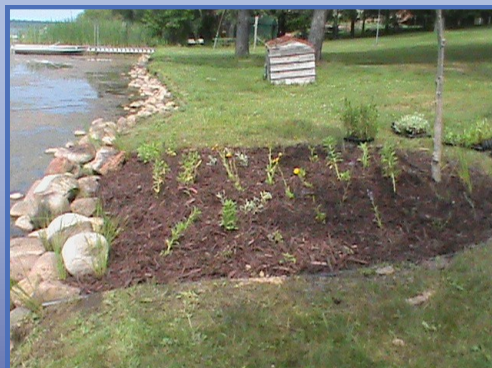
These practices will benefit habitat and water quality. In addition, the elaborate root system of the established native plant community will increase shoreline stability.
