2014 Annual Report

East Bethel – Ham Lake – Linwood - Columbus

April 13, 2015

Chapter 2: Sunrise River Watershed

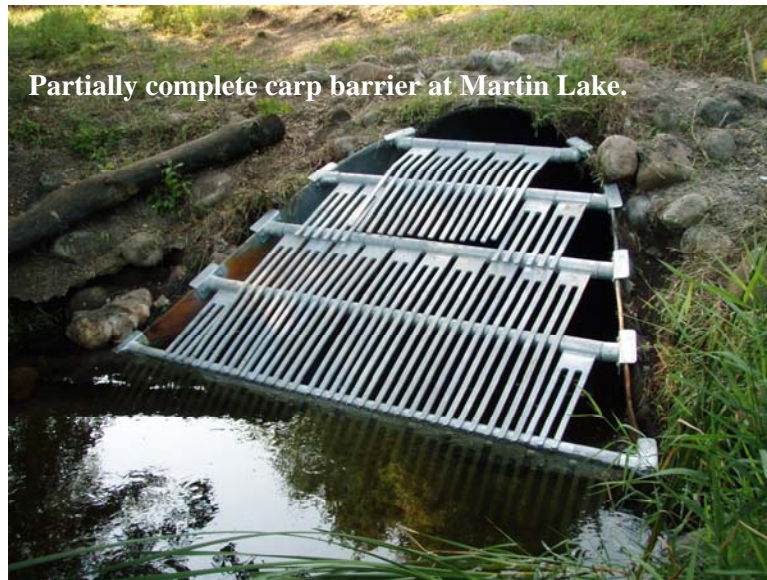
Martin and Typo Lake Carp Barriers (2012-15)

A series of four barriers are being installed to control carp in Martin and Typo Lakes in order to improve water quality and habitat. As of the end of 2014, one barrier has been installed. The remaining three will be installed in 2015. This project is funded by \$435,753 in MN DNR Conservation Partners Legacy grants, the Sunrise River WMO, Martin Lakers Association and Anoka Conservation District.

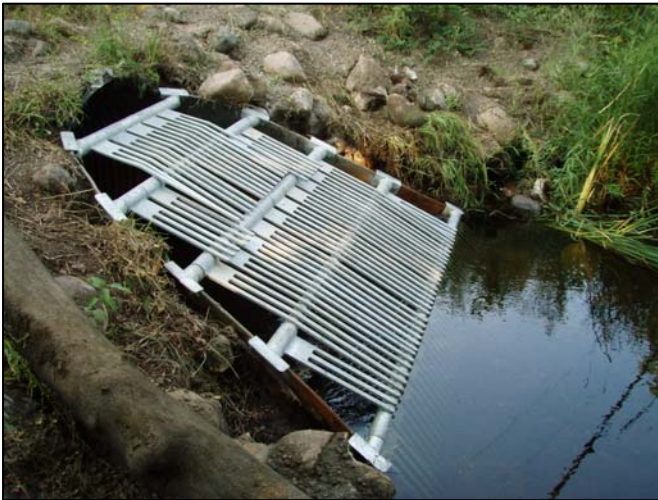
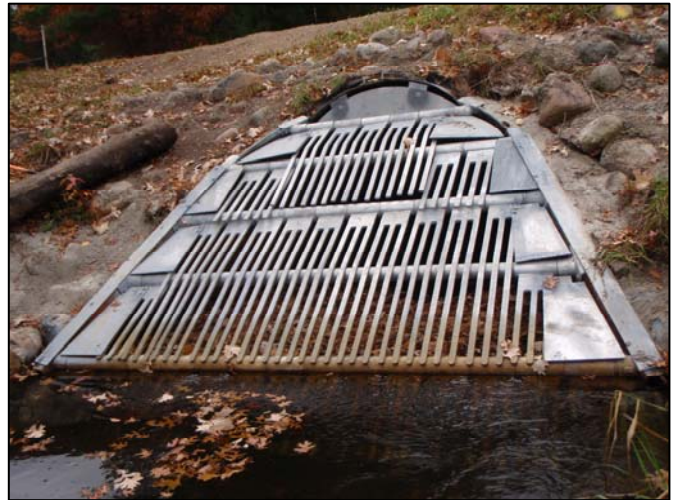
During and completed installation of first barrier.

Description: This project will improve water quality in Martin and Typo Lakes by controlling carp with strategically placed barriers and increased commercial harvests. Both lakes fail to meet state water quality standards due to excessive phosphorus which fuels algae blooms. As a result, the lakes are often strongly green or brown and the game fishery is depressed. Carp are a major cause of poor water quality in these lakes, diminishing their value for swimming, boating, and fishing.

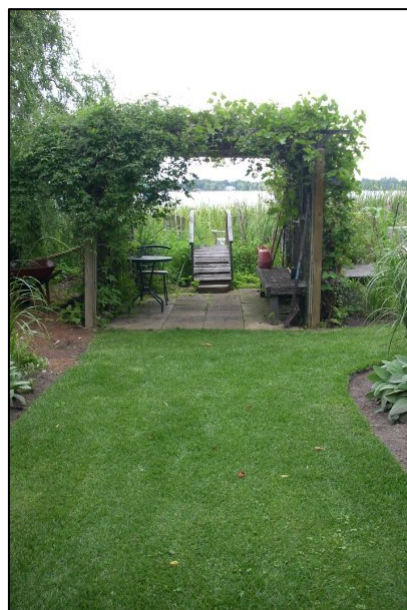
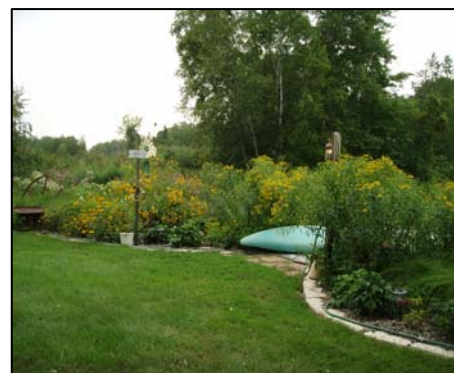
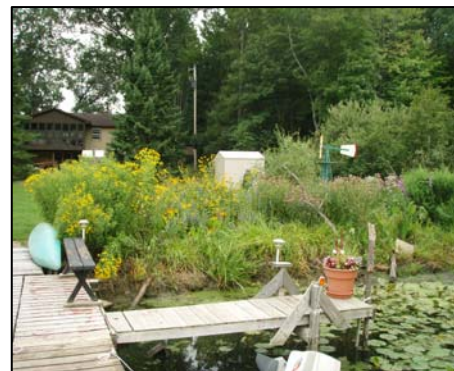
Lakeshore restoration at the Rogers Residence. Coon Lake.
