2015 Annual Report

East Bethel – Ham Lake – Linwood - Columbus

April 27, 2016

Prepared by the Anoka Conservation District

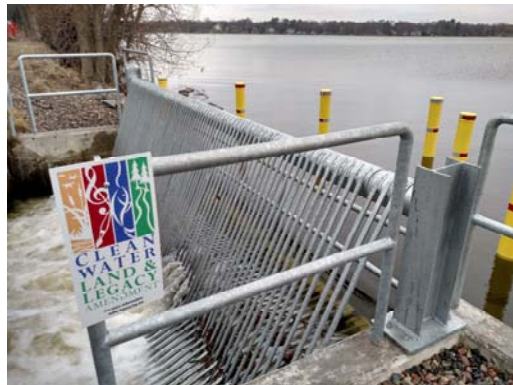
Martin Lake Outlet

Completed carp barriers

Results: In 2014 the SRWMO installed one carp barrier at the south inlet of Martin Lake. In 2015 three additional barriers were installed at the following locations: Typo Lake outlet, Martin Lakes' north inlet, and Martin Lake outlet. Construction will conclude in early 2016.

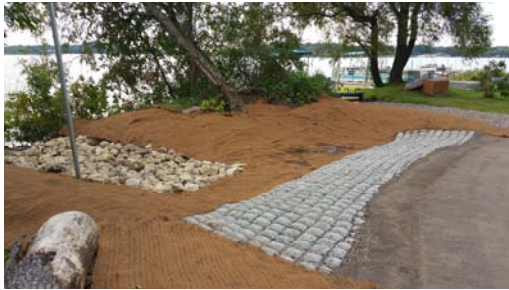
Lincoln Drive Stabilization

Two rain gardens, one stormwater stabilization and three lakeshore restorations will be installed in neighborhoods draining to Coon Lake in 2015 and 2016. These were among the most highly cost effective projects identified in the 2013 Coon Lake Subwatershed Assessment. These projects are funded by a \$42,987 2014 BWSR Clean Water Fund Grant, the SRWMO, Coon Lake Improvement District, Coon Lake Improvement Association and Coon Lake Beach Community Center.
