# 2016 Annual Report

**East Bethel – Ham Lake – Linwood - Columbus**

**April 17, 2017**

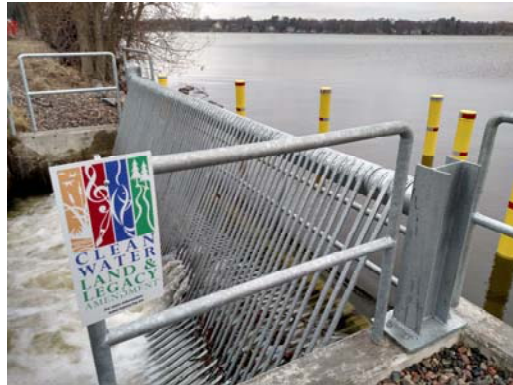
Martin Lake Outlet

A series of four barriers has been installed to control carp in Martin and Typo Lakes in order to improve water quality and habitat. This project is funded by \$435,753 in MN DNR Conservation Partners Legacy grants, the Sunrise River WMO, Martin Lakers Association and Anoka Conservation District. The same funding partners are teaming to follow this project with a carp removal program in 2017-2019.

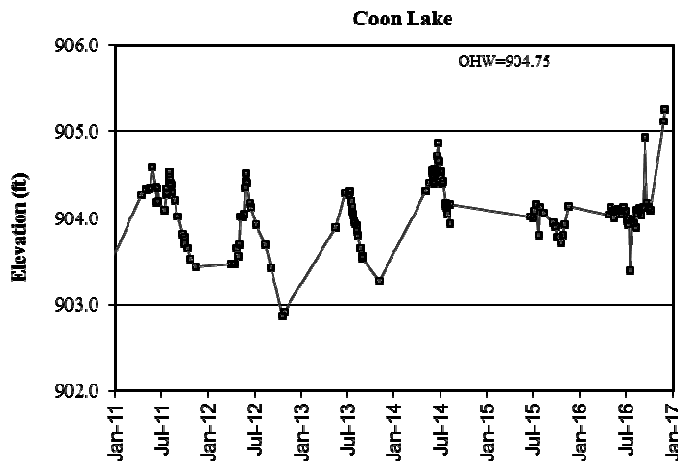
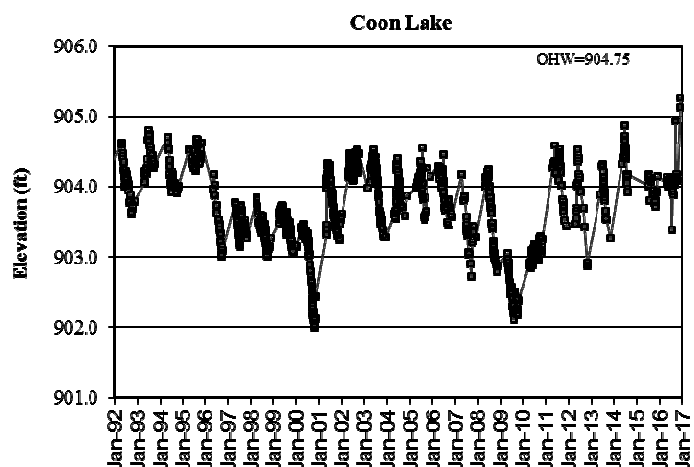
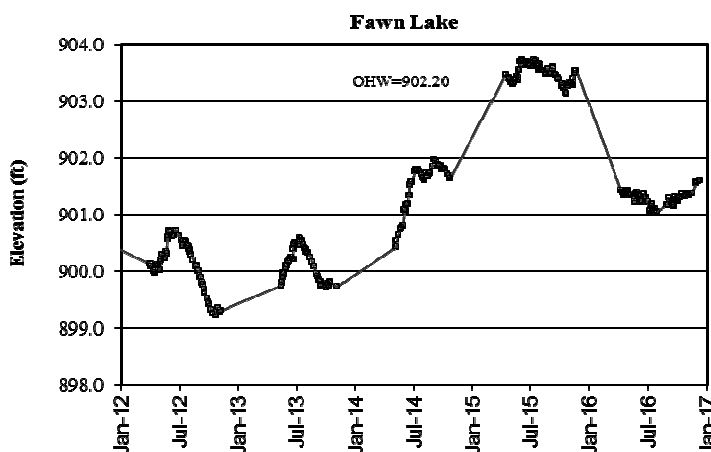
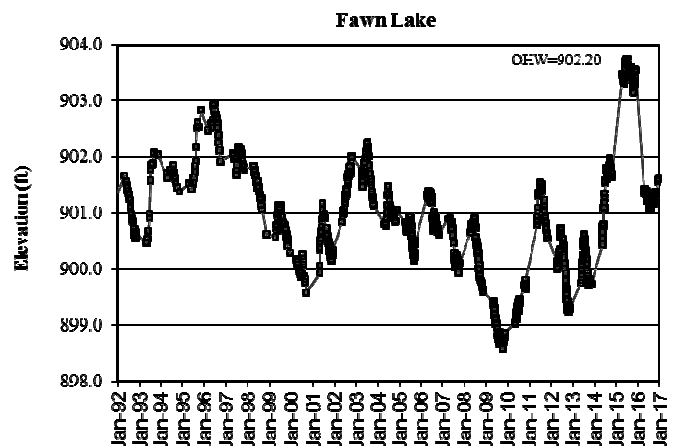
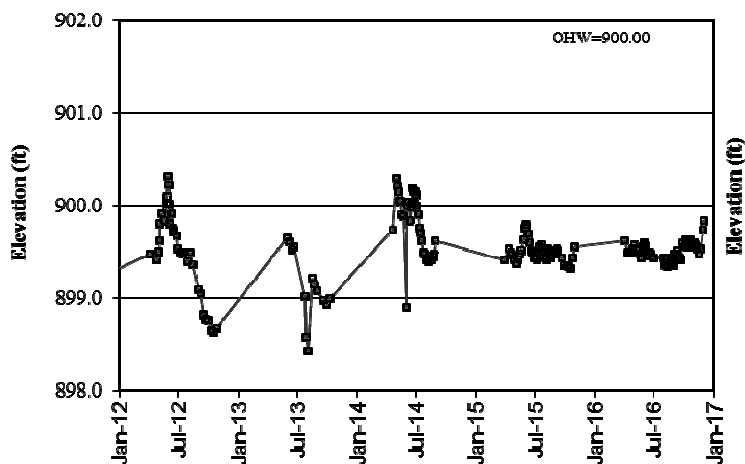
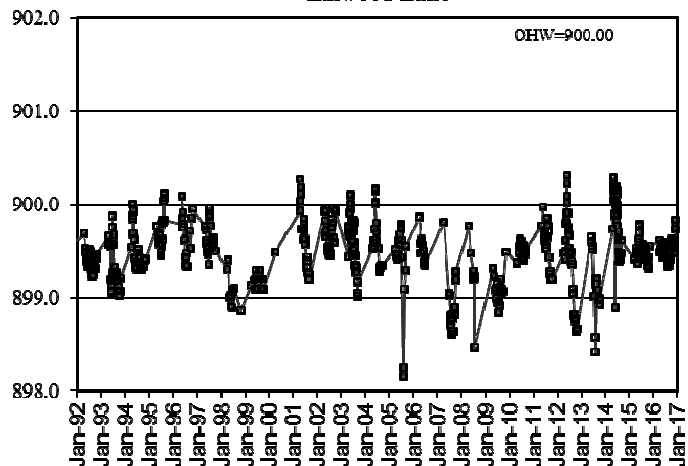
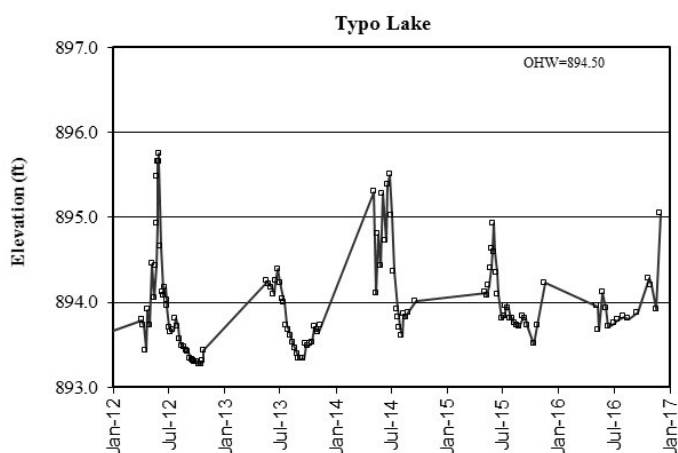
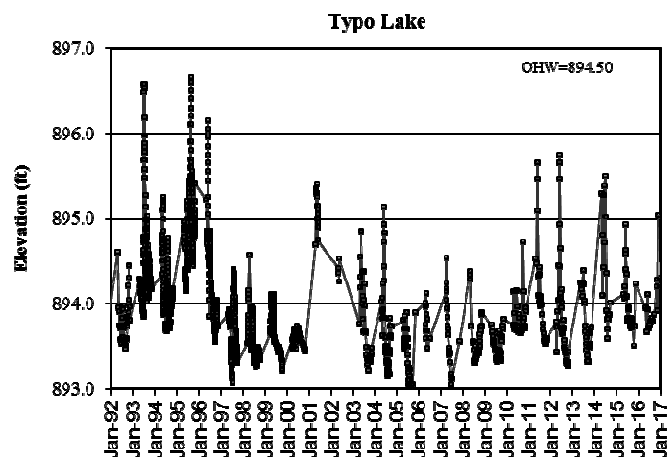
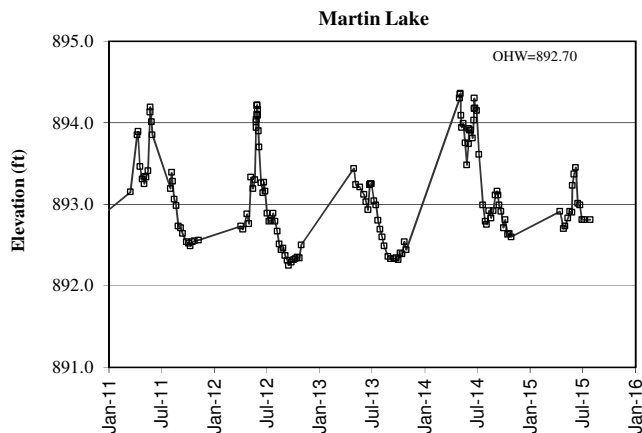
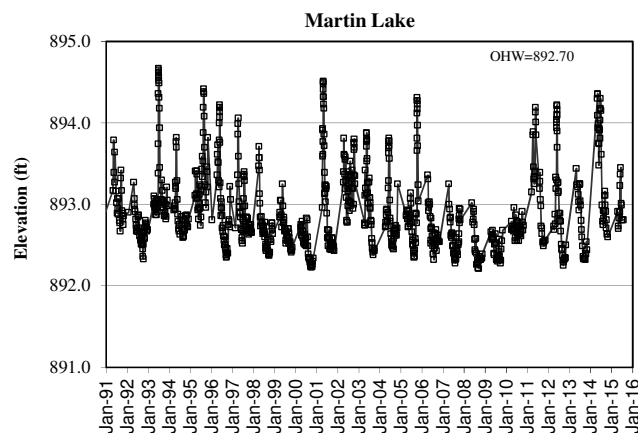
**Results:** Lake levels were measured by volunteers throughout the 2016 open water season. Lake gauges were installed and surveyed by the Anoka Conservation District and MN DNR. Lakes followed the expected pattern of increasing water levels in spring and early summer and then fell later in the summer due to less rainfall. High rainfall amounts late into fall caused a spike in lake levels at the end of the year. Coon and Fawn Lakes had their highest water levels in more than 25 years. Average lake levels were similar or slightly higher than 2015.

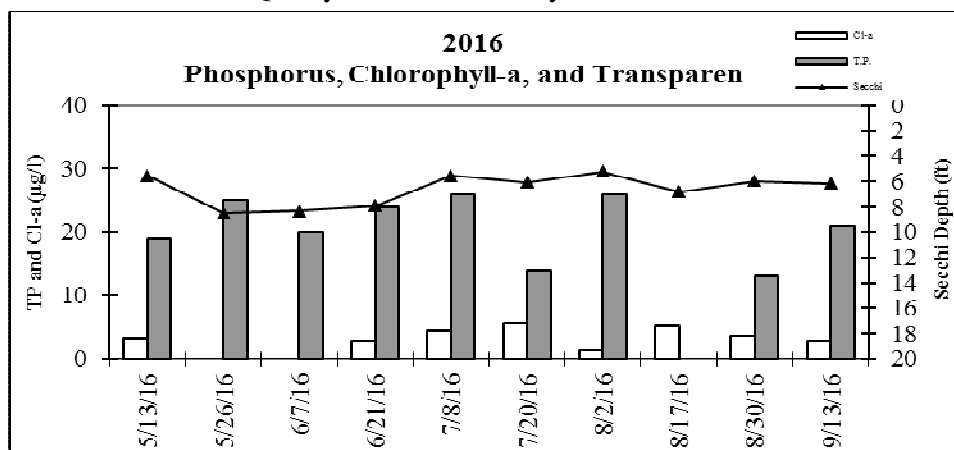
## 2016 Water Quality Results- West Bay

In 2016 the West Bay had better than average water quality for this region of the state (NCHF Ecoregion), receiving an A- letter grade. Average values of water quality parameters included 21.0 µg/L for total phosphorus, 3.6 µg/L of chlorophyll-a, and Secchi transparency of 6.6 feet. Average total phosphorus levels were the lowest of all monitored years, and only 2014 chlorophyll-a levels were lower than those measured in 2016. Secchi transparency had its second best average of the last twelve years; only beat out by the 2014 average of 6.9 feet.

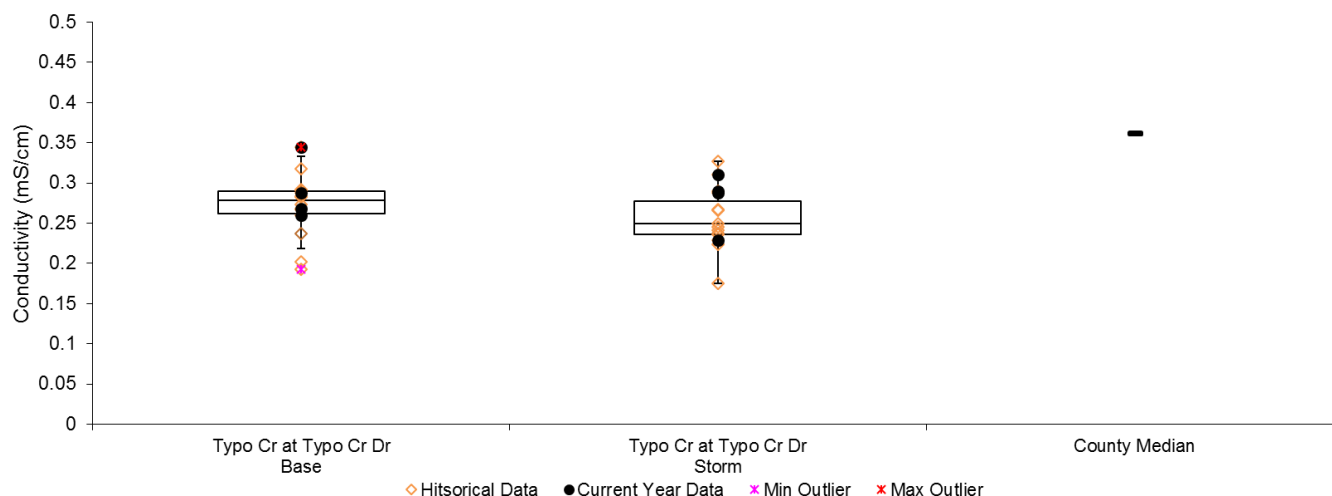
Conductivity was acceptably low in Typo Creek, averaging 0.285 mS/cm over the sampling season. This is notably lower than the median for 34 Anoka County streams of 0.362 mS/cm. Conductivity was slightly lower during storms, suggesting that stormwater runoff contains fewer dissolved pollutants than the surficial water table that feeds the river during baseflow. High baseflow conductivity has been observed in many other area streams with the largest cause believed to be road salts that have infiltrated into the shallow aquifer.

**Conductivity during baseflow and storm conditions.** Orange diamonds are historical data from previous years and black circles are 2016 readings. Box plots show the median (middle line), 25<sup>th</sup> and 75<sup>th</sup> percentile (ends of box), and 10<sup>th</sup> and 90<sup>th</sup> percentiles (floating outer lines).

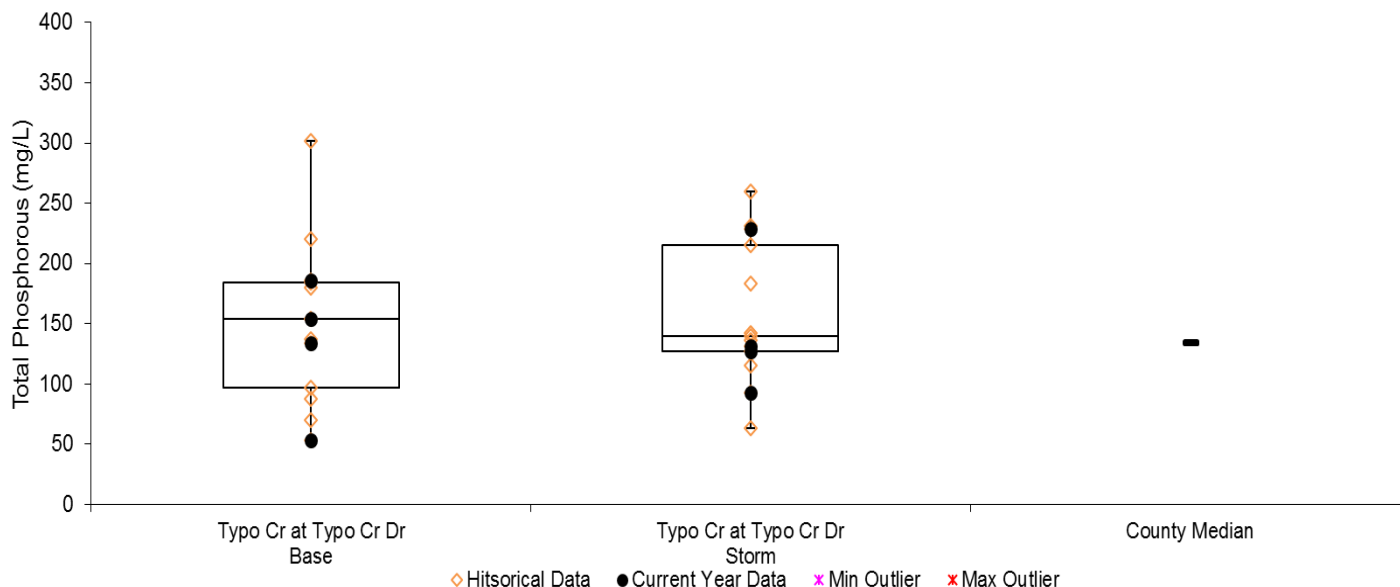
Total phosphorus (TP), a nutrient, is one of the most common pollutants in our region, and can be associated with urban runoff, agricultural runoff, wastewater, and many other sources. The average total phosphorus concentration of Typo Creek in 2016 was 138 ug/L, well in exceedance of the state standard (100 ug/L). These high phosphorus levels are common for the area. In the case of Typo Creek, phosphorus levels are also reflective of conditions of Typo Lake upstream. A TMDL was approved for Typo Creek in 2012 for pH and turbidity before the current stream eutrophication standards applied. Nutrients are the primary cause of high turbidity and pH. Nutrient reduction projects are ongoing.

**Total phosphorus during baseflow and storm conditions.** Orange diamonds are historical data from previous years and black circles are 2016 readings. Box plots show the median (middle line), 25<sup>th</sup> and 75<sup>th</sup> percentile (ends of box), and 10<sup>th</sup> and 90<sup>th</sup> percentiles (floating outer lines).

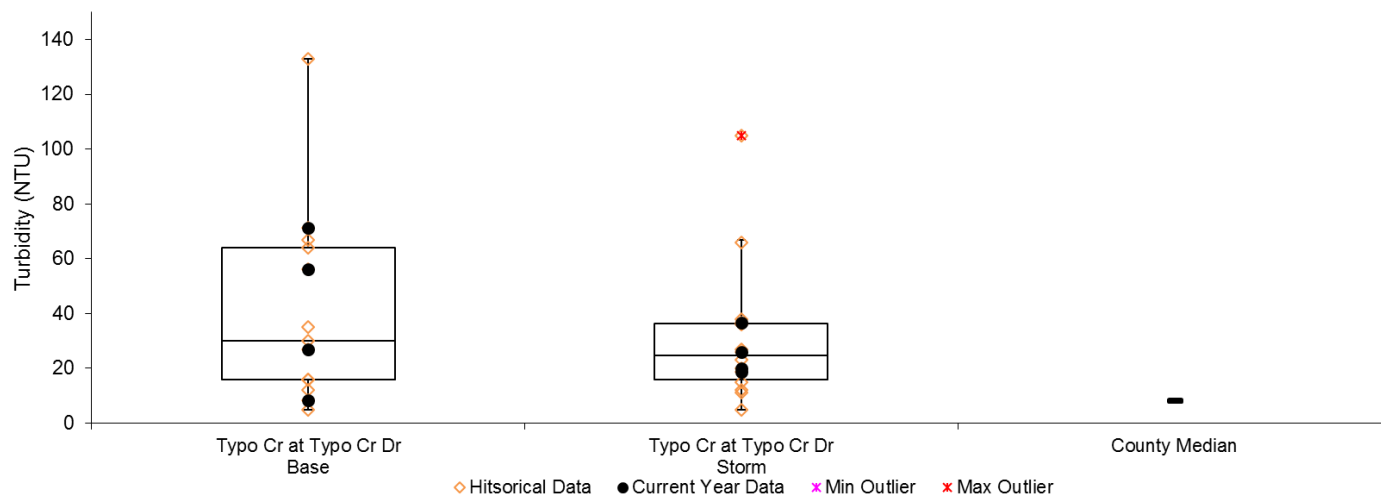
The high turbidity levels in Typo Creek are likely due to many factors within the watershed. Rough fish are present in the creek, as well as each of the lakes it connects. Typo Lake upstream is hypertrophic, and MN DNR fisheries anecdotal notes suggest large algae blooms dating back to the 1960s. Additionally, Typo Creek and Typo Lake each have a very loose, unconsolidated, silty bottom that easily mixes with the water column and readily remains suspended.

**Turbidity during baseflow and storm conditions** Orange diamonds are historical data from previous years and black circles are 2016 readings. Box plots show the median (middle line), 25<sup>th</sup> and 75<sup>th</sup> percentile (ends of box), and 10<sup>th</sup> and 90<sup>th</sup> percentiles (floating outer lines).

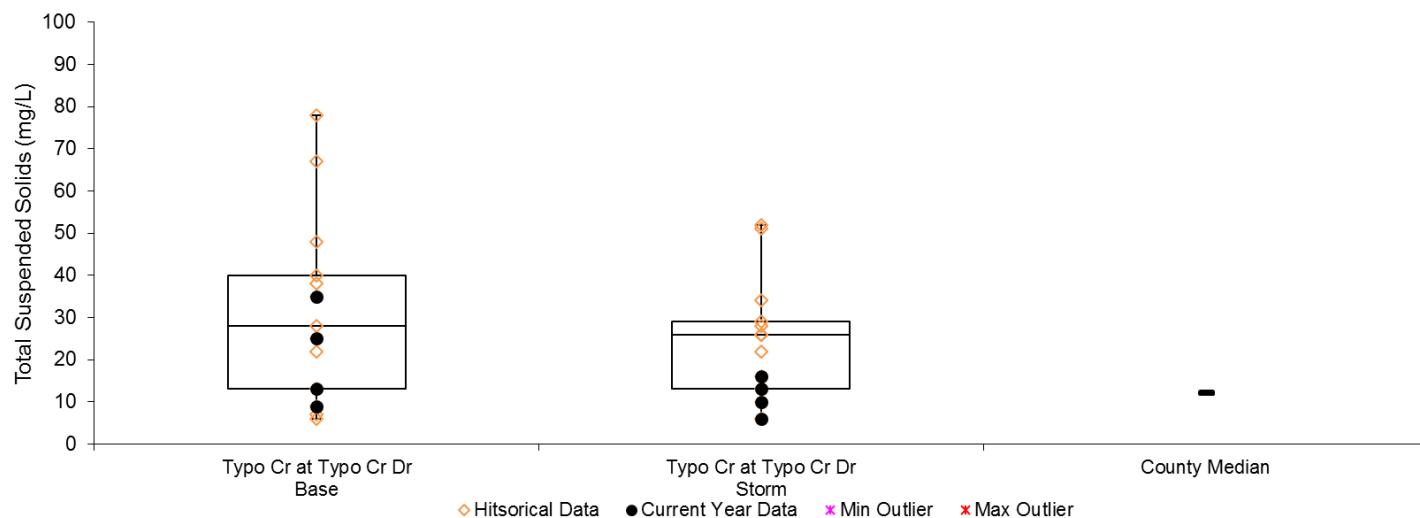
Turbidity and total suspended solids (TSS) are two different measurements of solid material suspended in the water. Turbidity is measured by refraction of a light beam passed through a water sample. It is most sensitive to large particles. Total suspended solids is measured by filtering solids from a water sample and weighing the filtered material. The amount of suspended material is important because it affects transparency and aquatic life, and because many other pollutants are attached to particles. Many stormwater treatment practices such as street sweeping, sumps, and stormwater settling ponds target sediment and attached pollutants.

**Total suspended solids during baseflow and storm conditions** Orange diamonds are historical data from previous years and black circles are 2016 readings. Box plots show the median (middle line), 25<sup>th</sup> and 75<sup>th</sup> percentile (ends of box), and 10<sup>th</sup> and 90<sup>th</sup> percentiles (floating outer lines).

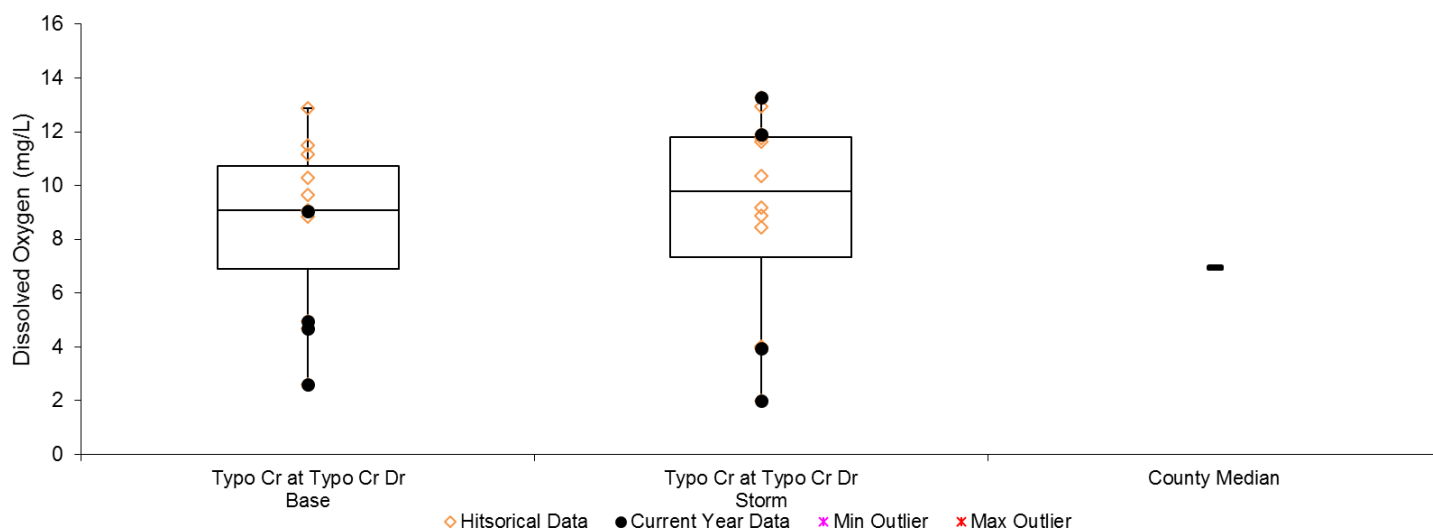
In three past years of sampling, Typo Creek only had a DO level below 5 mg/L on one occasion. In 2016, five of eight samples yielded sub-5 mg/L results. These results are especially disconcerting considering low DO was measured during both storm and baseflow conditions during a year that was generally wet but without flooding. These low DO concentrations are likely directly attributable to decomposition, eutrophication and lack of clarity within the stream. These conditions cause high levels of oxygen consumption without allowing sunlight to penetrate the water column and trigger photosynthesis.

**Dissolved oxygen results during baseflow and storm conditions** Orange diamonds are historical data from previous years and black circles are 2016 readings. Box plots show the median (middle line), 25<sup>th</sup> and 75<sup>th</sup> percentile (ends of box), and 10<sup>th</sup> and 90<sup>th</sup> percentiles (floating outer lines).

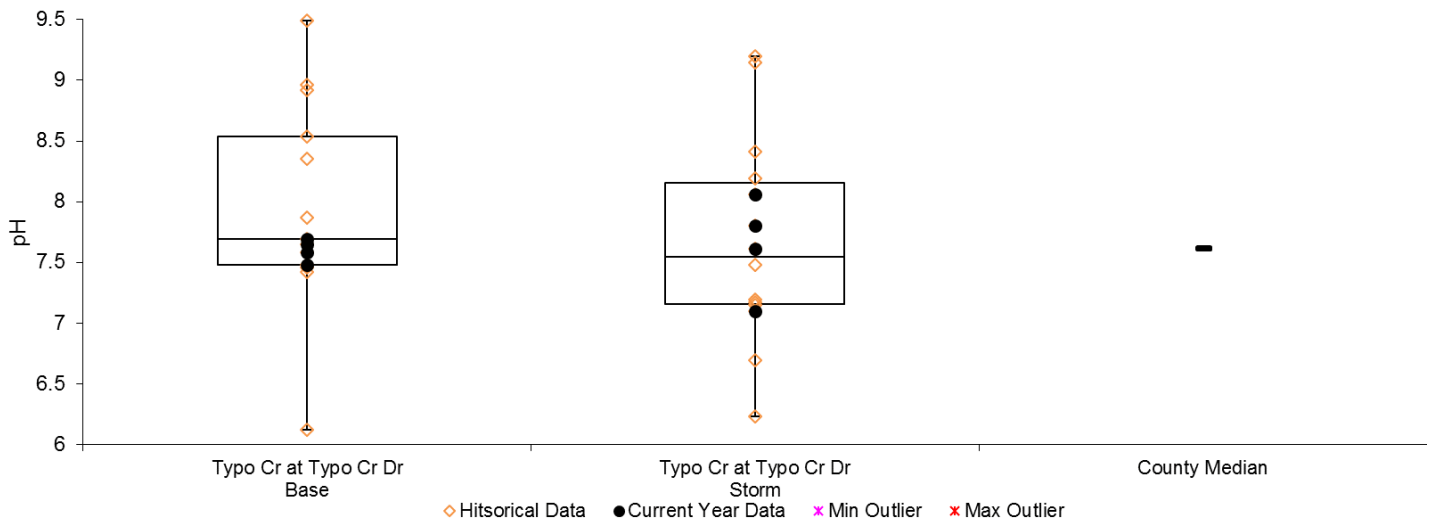
**pH results during baseflow and storm conditions** Orange diamonds are historical data from previous years and black circles are 2016 readings. Box plots show the median (middle line), 25<sup>th</sup> and 75<sup>th</sup> percentile (ends of box), and 10<sup>th</sup> and 90<sup>th</sup> percentiles (floating outer lines).

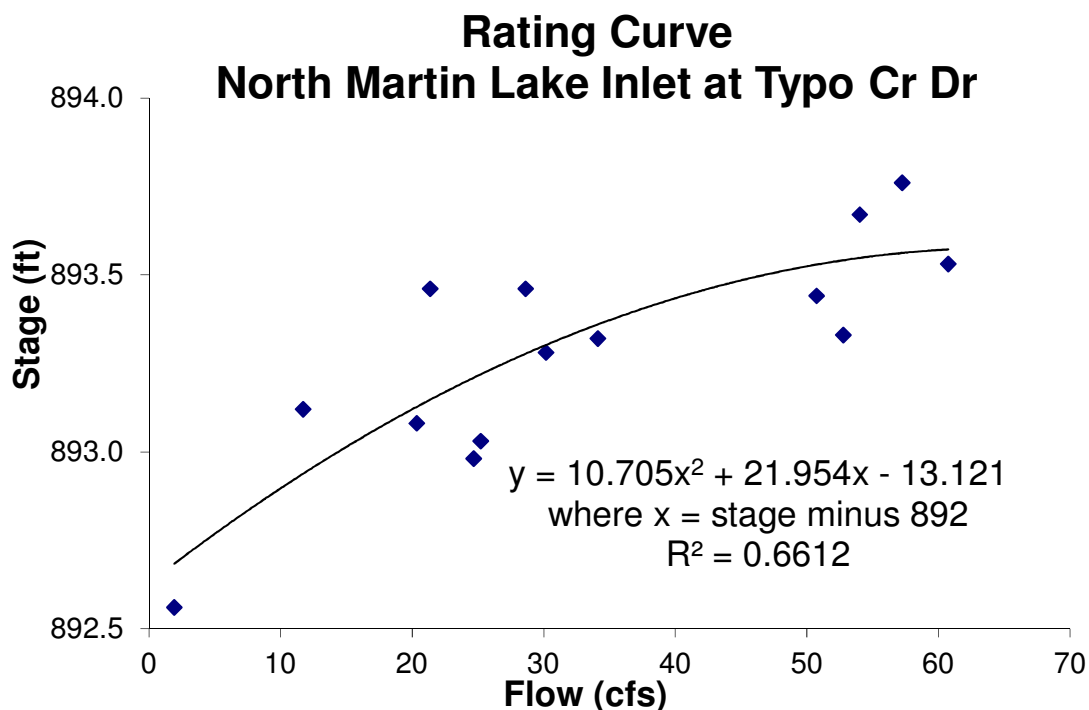
**Results:** Rating curves were developed for the site listed above in previous years. In 2012 ACD staff discovered an error in the equations and corrected them. They also corrected all past hydrology records that used the equations. Below are the corrected rating curves.

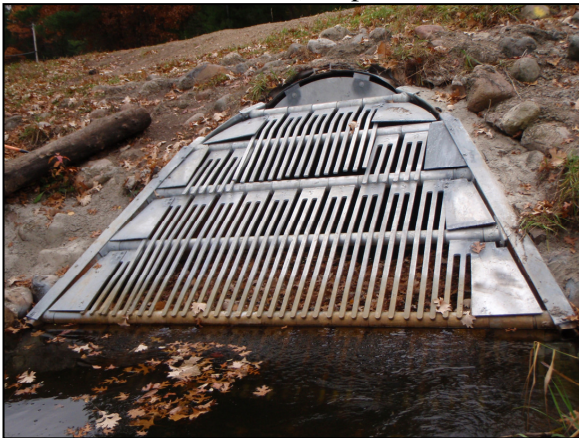
Martin Lake south inlet (completed 2014)

**Description:** This project aims to improve water quality in Martin and Typo Lakes by controlling carp with strategically placed barriers and increased commercial harvests. Both lakes fail to meet state water quality standards due to excessive phosphorus, which fuels algae blooms. As a result, the lakes are often strongly green or brown and the game fishery is depressed. Carp are a major cause of poor water quality in these lakes, diminishing their value for swimming, boating, and fishing.
