# LINWOOD LAKE TRIBUTARIES

Water Quality Analysis

ANOCA CONSERVATION DISTRICT  
DECEMBER, 2024

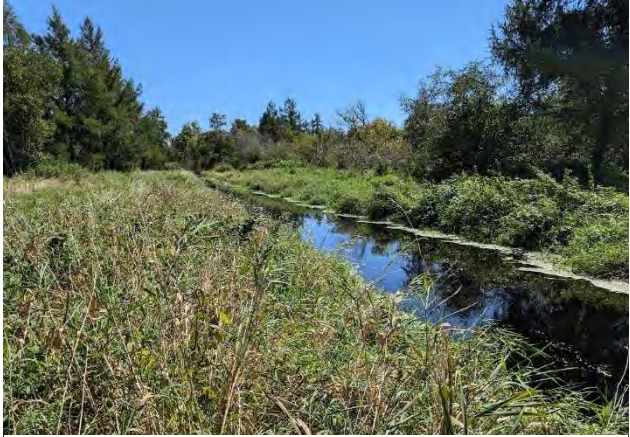
Figure 2: Rice Lake Inlet (downstream)

**Rice Lake Inlet** is located approximately 2,400 feet upstream from Rice Lake, and approximately 300 feet downstream from tributary ditches. Landowner permission was granted to collect samples from private property. This site is characterized by its slow flow, deep water, and a mucky bottom.

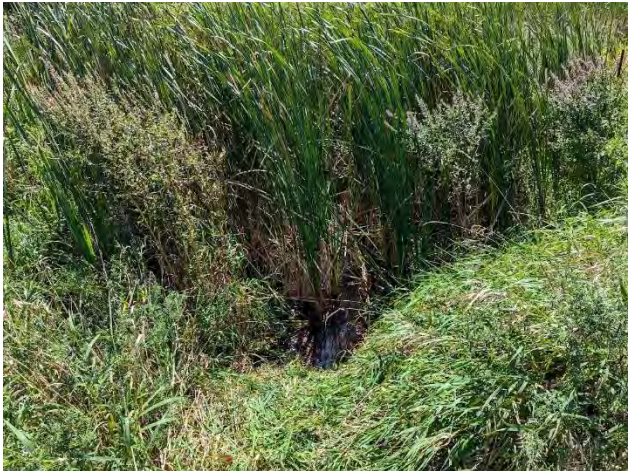
Figure 3: Linwood Lake Inlet @ AMA (upstream)

**Linwood Lake Inlet @ AMA** is located approximately 1,400 feet upstream from Linwood Lake, and immediately downstream from the a DNR aquatic managed area (AMA) which contains a pond. Samples were collected at the culvert on the downstream side of Viking Blvd. This site is characterized by its slow flow, mucky bottom, frequently stagnant surface water, and abundant emergent aquatic vegetation.

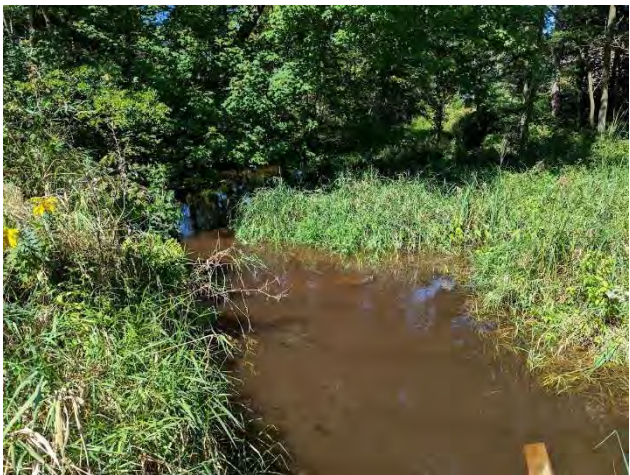
Figure 4: Boot Lake Inlet (upstream)

**Boot Lake Inlet** is approximately 750 feet upstream from Boot Lake and 600 feet downstream of Rice Lake. Samples were collected at the culvert on the upstream side of Viking Blvd. This site is characterized by its relatively normal flow compared to the other two sites.

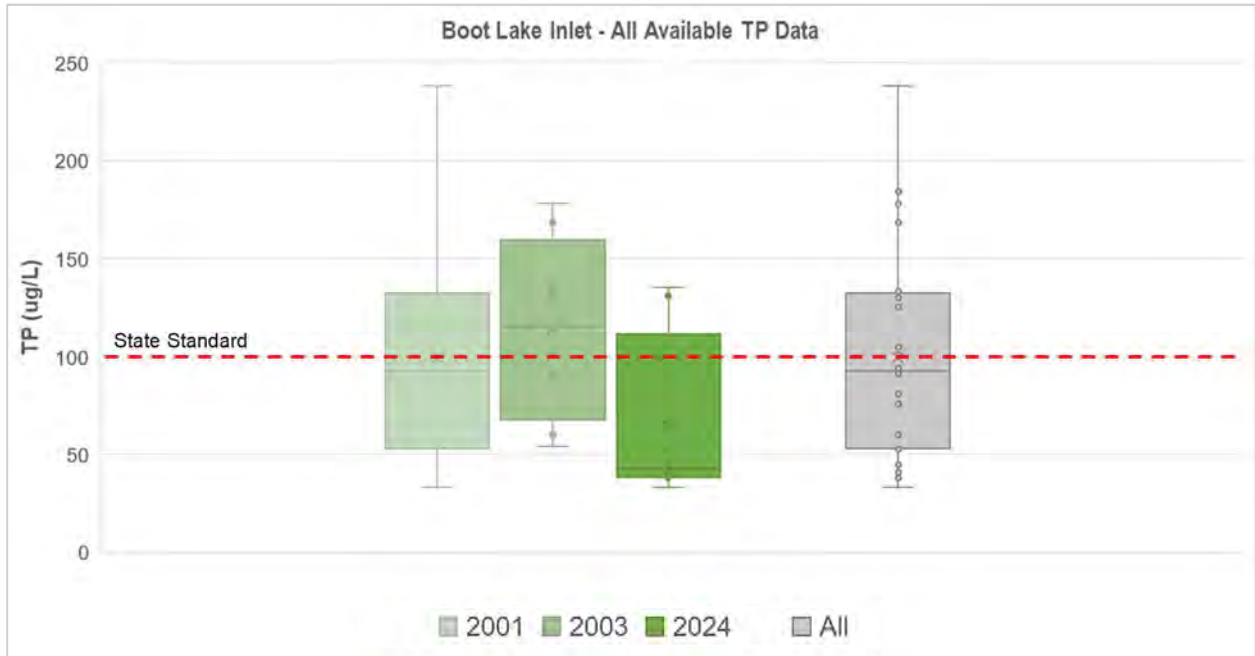
Except for *Boot Lake Inlet*, there is no available historical data for total phosphorous. 2001 and 2003 data are available for *Boot Lake Inlet*. The results are shown in the box-and-whisker graph below. In general, total phosphorous hovers around the state standard of 100  $\mu\text{g/L}$ , but is frequently sampled below this value. Overall, the 2024 data and this historic data are similar and suggest that high phosphorous is not problematic in the *Boot Lake* subwatershed.

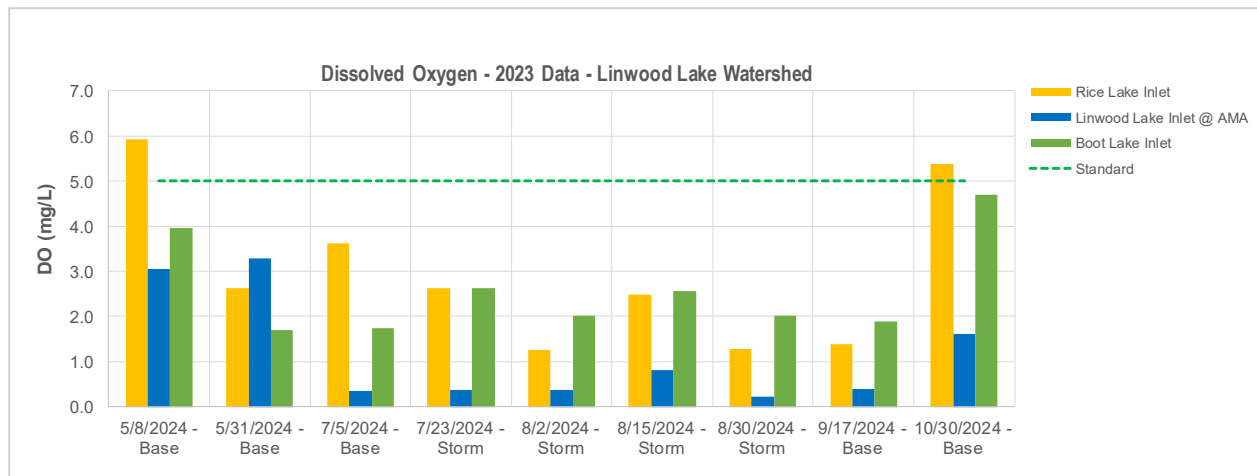
In 2024, DO levels at all three sites during all conditions averaged 2.34 mg/L with a median of 1.89 mg/L. Average values for specific sites during baseflow and post-storm conditions can be found in the table below.

In general, DO levels were almost entirely (25 out of 27 total occasions) below the state standard of 5 mg/L. The low dissolved oxygen levels are likely the result of decomposition in adjacent wetlands. The water has a lot of contact with decaying organic matter which can strip the water of oxygen. As a result, identifying projects for the purpose of increasing low oxygen impairment is difficult, and the scope of any such projects would need to be large.

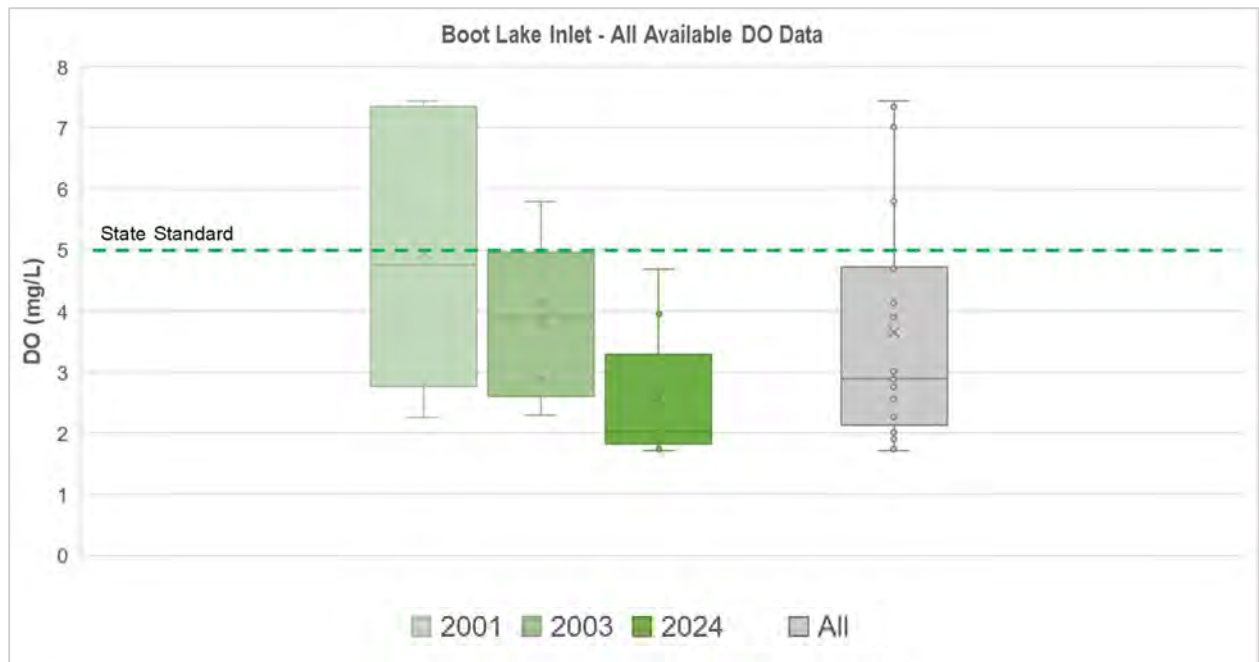
Except for *Boot Lake Inlet*, there is no available historical data for dissolved oxygen. 2001 and 2003 data are available for *Boot Lake Inlet*. The results are shown in the box-and-whisker graph below. In general, average DO levels are below the state standard of 5 mg/L.

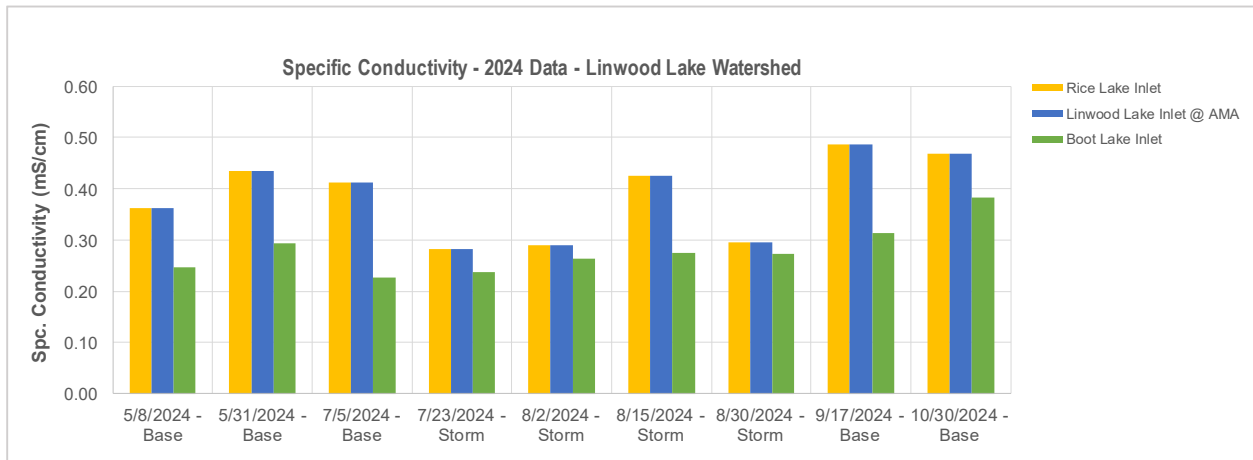
Miscellaneous data, such as pH, turbidity, and specific conductivity, are available below. Overall, there is nothing concerning about this data that warrants further investigation.

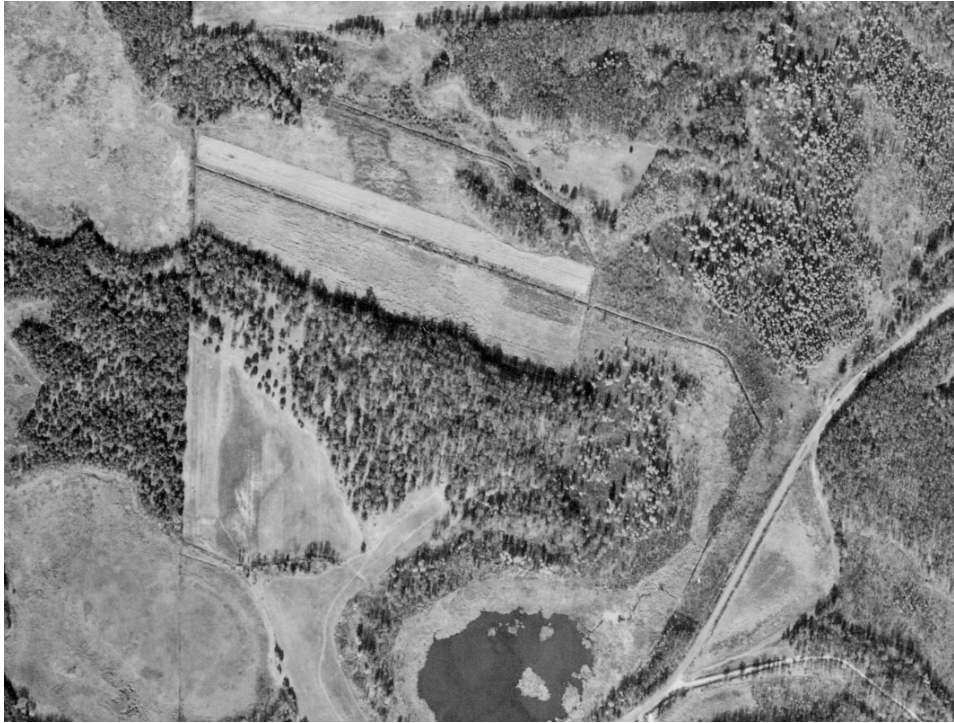
**Figure 6:** Historical 1960 photo of ditch network upstream of DNR's aquatic management area.

Another potential practice is ditch blocks within the wetland-complex upstream of the DNR's aquatic management area. As shown in Figure 6 below, this area had a history of being cropped or harvested for sod or hay. Those ditch-dependent land uses have been abandoned. The scope and extent of drainage of the wetland soils could be reduced with ditch blocks, particularly for lateral ditches. This could reduce phosphorus export from those partially drained wetland soils. These ditches are on private lands, and willingness from all affected landowners would be needed.
