# SCHEIDERICH LAKESHORE RESTORATION EAST BETHEL, MN

Lakeshore Restoration

## Project Summary

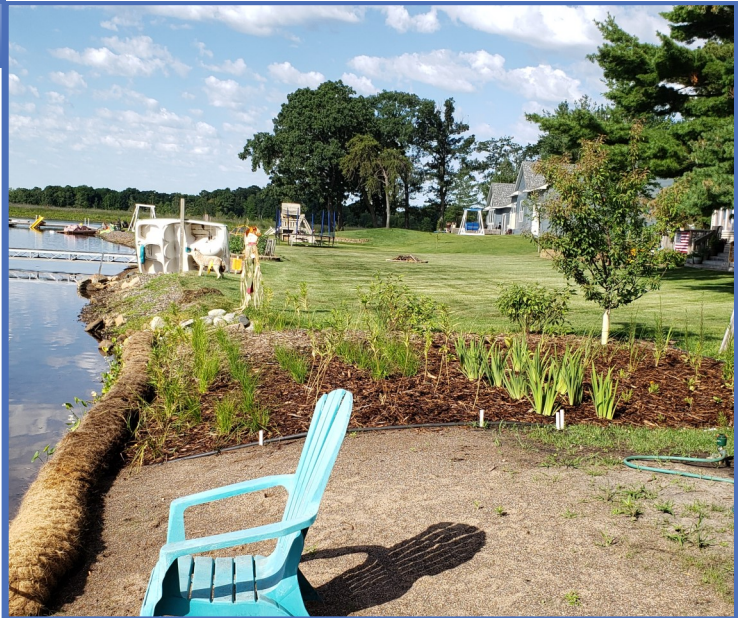
Project just after completion in the summer of 2020.

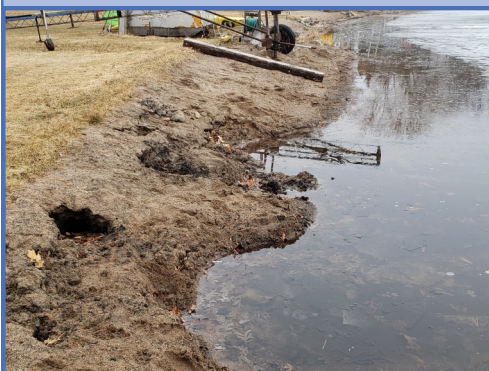
Pre-restoration conditions consisted of an eroding bank, mowed turf and a failed beach area. This provided little benefit to Coon Lake water quality, contributed minimal wildlife habitat and did not help shoreline stability.

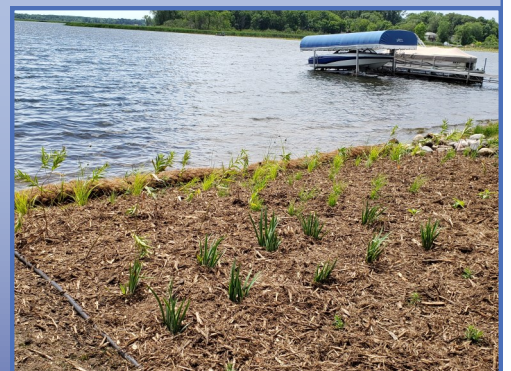
The native vegetated buffer will improve water quality in Coon Lake, increase wildlife habitat and improve biodiversity. In addition, the deep root system of the established native plant community will increase shoreline stability.
