GUSTAFSON LAKESHORE RESTORATION WYOMING, MN

Project Summary

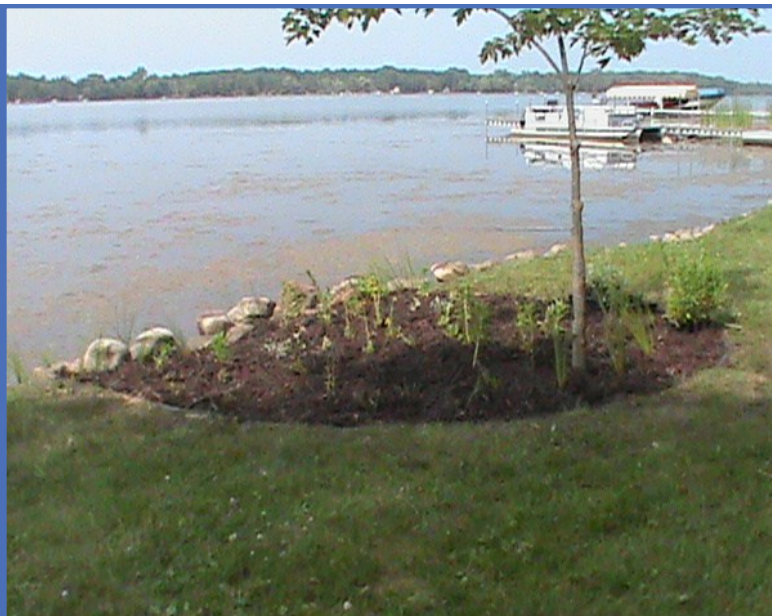
Completed project in the summer of 2012.

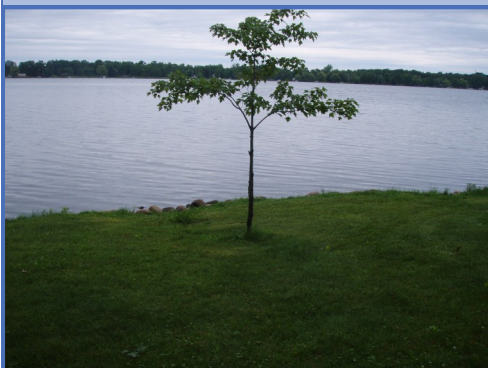
Pre-restoration conditions consisted of mown turf grass and Creeping Charlie, which provided no benefits to water quality, wildlife habitat, or shoreline stability.

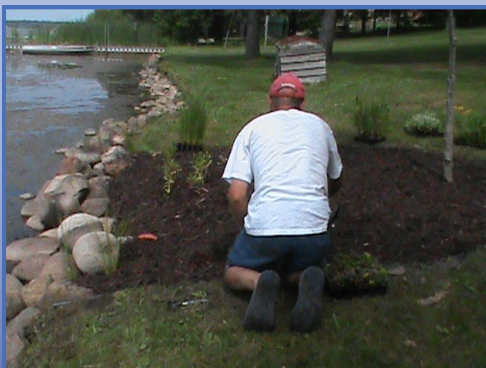
Sod was removed prior to the installation of erosion control blanket, shredded hardwood mulch, landscape edging, and native plant plugs.

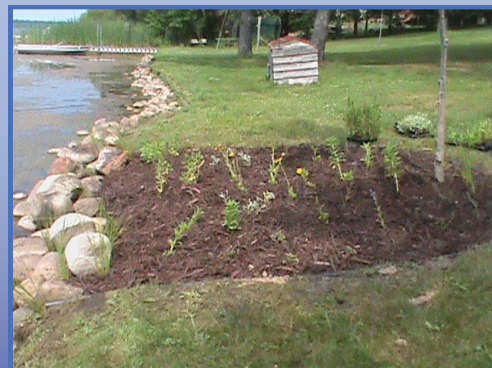
These practices will benefit habitat and water quality. In addition, the elaborate root system of the established native plant community will increase shoreline stability.
